# CR335/CR303 SAFETY STUDY

CR335 (SPANGLER RD.) /  
CR303 (MEDWAY-NEW CARLISLE RD.)  
FROM RESTORATION PARK DR.  
TO US40 (W. NATIONAL RD.)

PREPARED FOR:  
CLARK COUNTY ENGINEER  
4075 LAYBOURNE RD.  
SPRINGFIELD, OHIO 45505  
AUGUST 2020

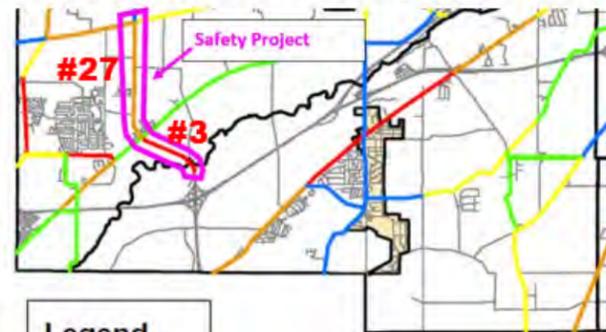
### 2016-2018 Rural Corridor Crash Locations

Clark County-Springfield TCC (Local MPO)  
**High Crash Corridor Rankings:**  
#3 (CR335 from Restoration Park to Lower Valley)  
#27 (CR303 from Lower Valley to US40)

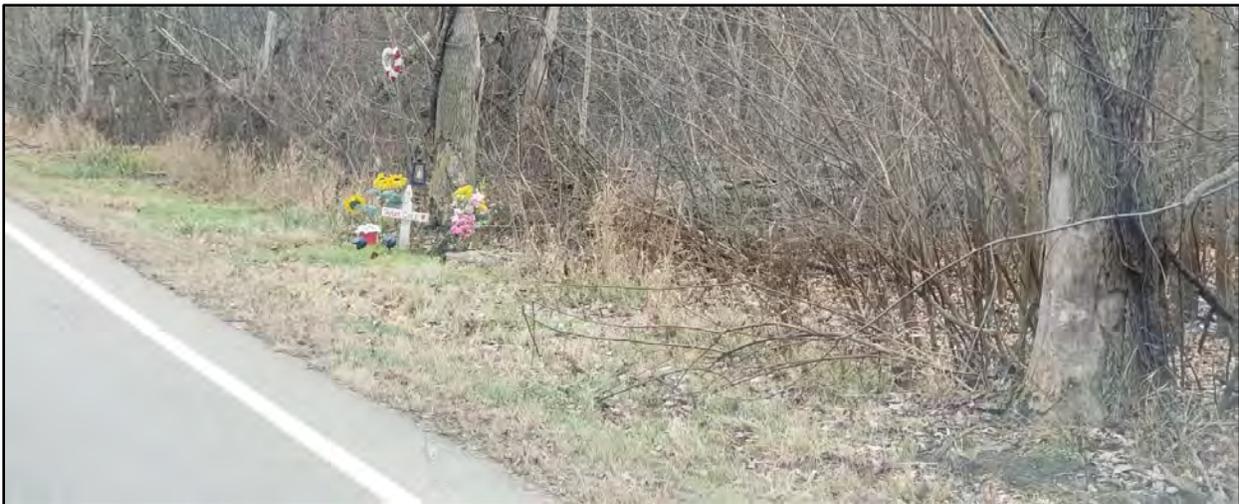
The picture below shows a roadside grave marker where a tree was struck by a vehicle that led to a fatality. The other large tree in the photograph also shows the bark torn away from another crash. The section of CR335 (Spangler Road) from South Union Road northward to the intersection with Main Street in Medway, Ohio has fixed objects that are within 3 to 5 feet of the travel lane.

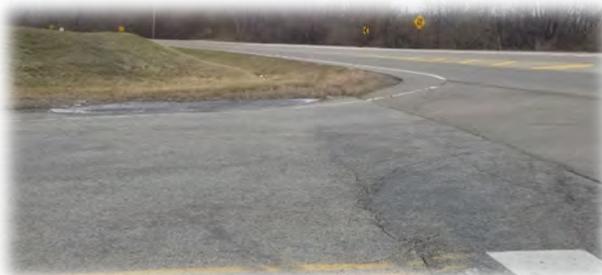
Limited sight distance at Restoration Park Drive looking northward for southbound traffic that is caused from the earth levee

Limited sight distance at Restoration Park Drive looking northward for southbound traffic that is caused from the earth levee

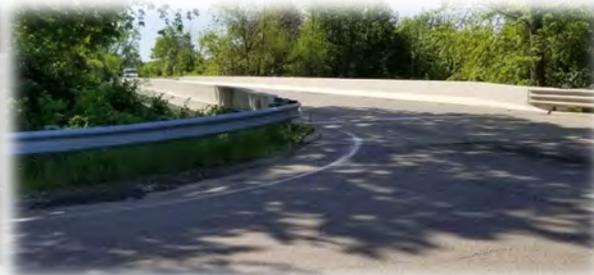
Limited sight distance at South Union Road looking southward for northbound traffic limited by intersection being too close to bridge

Limited sight distance at South Union Road looking southward for northbound traffic limited by intersection being too close to bridge

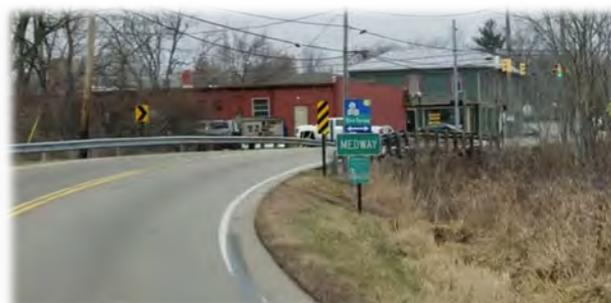
Sharp curve heading into small bridge structure entering Medway, that limits view of traffic signal (skid marks on roadway going into curve)

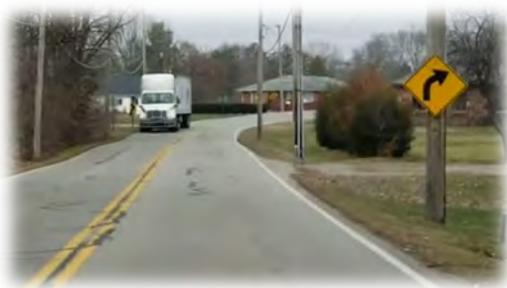
Curved sections within roadway corridor have limited shoulder widths and could use enhanced signing to warn motorists of the curves

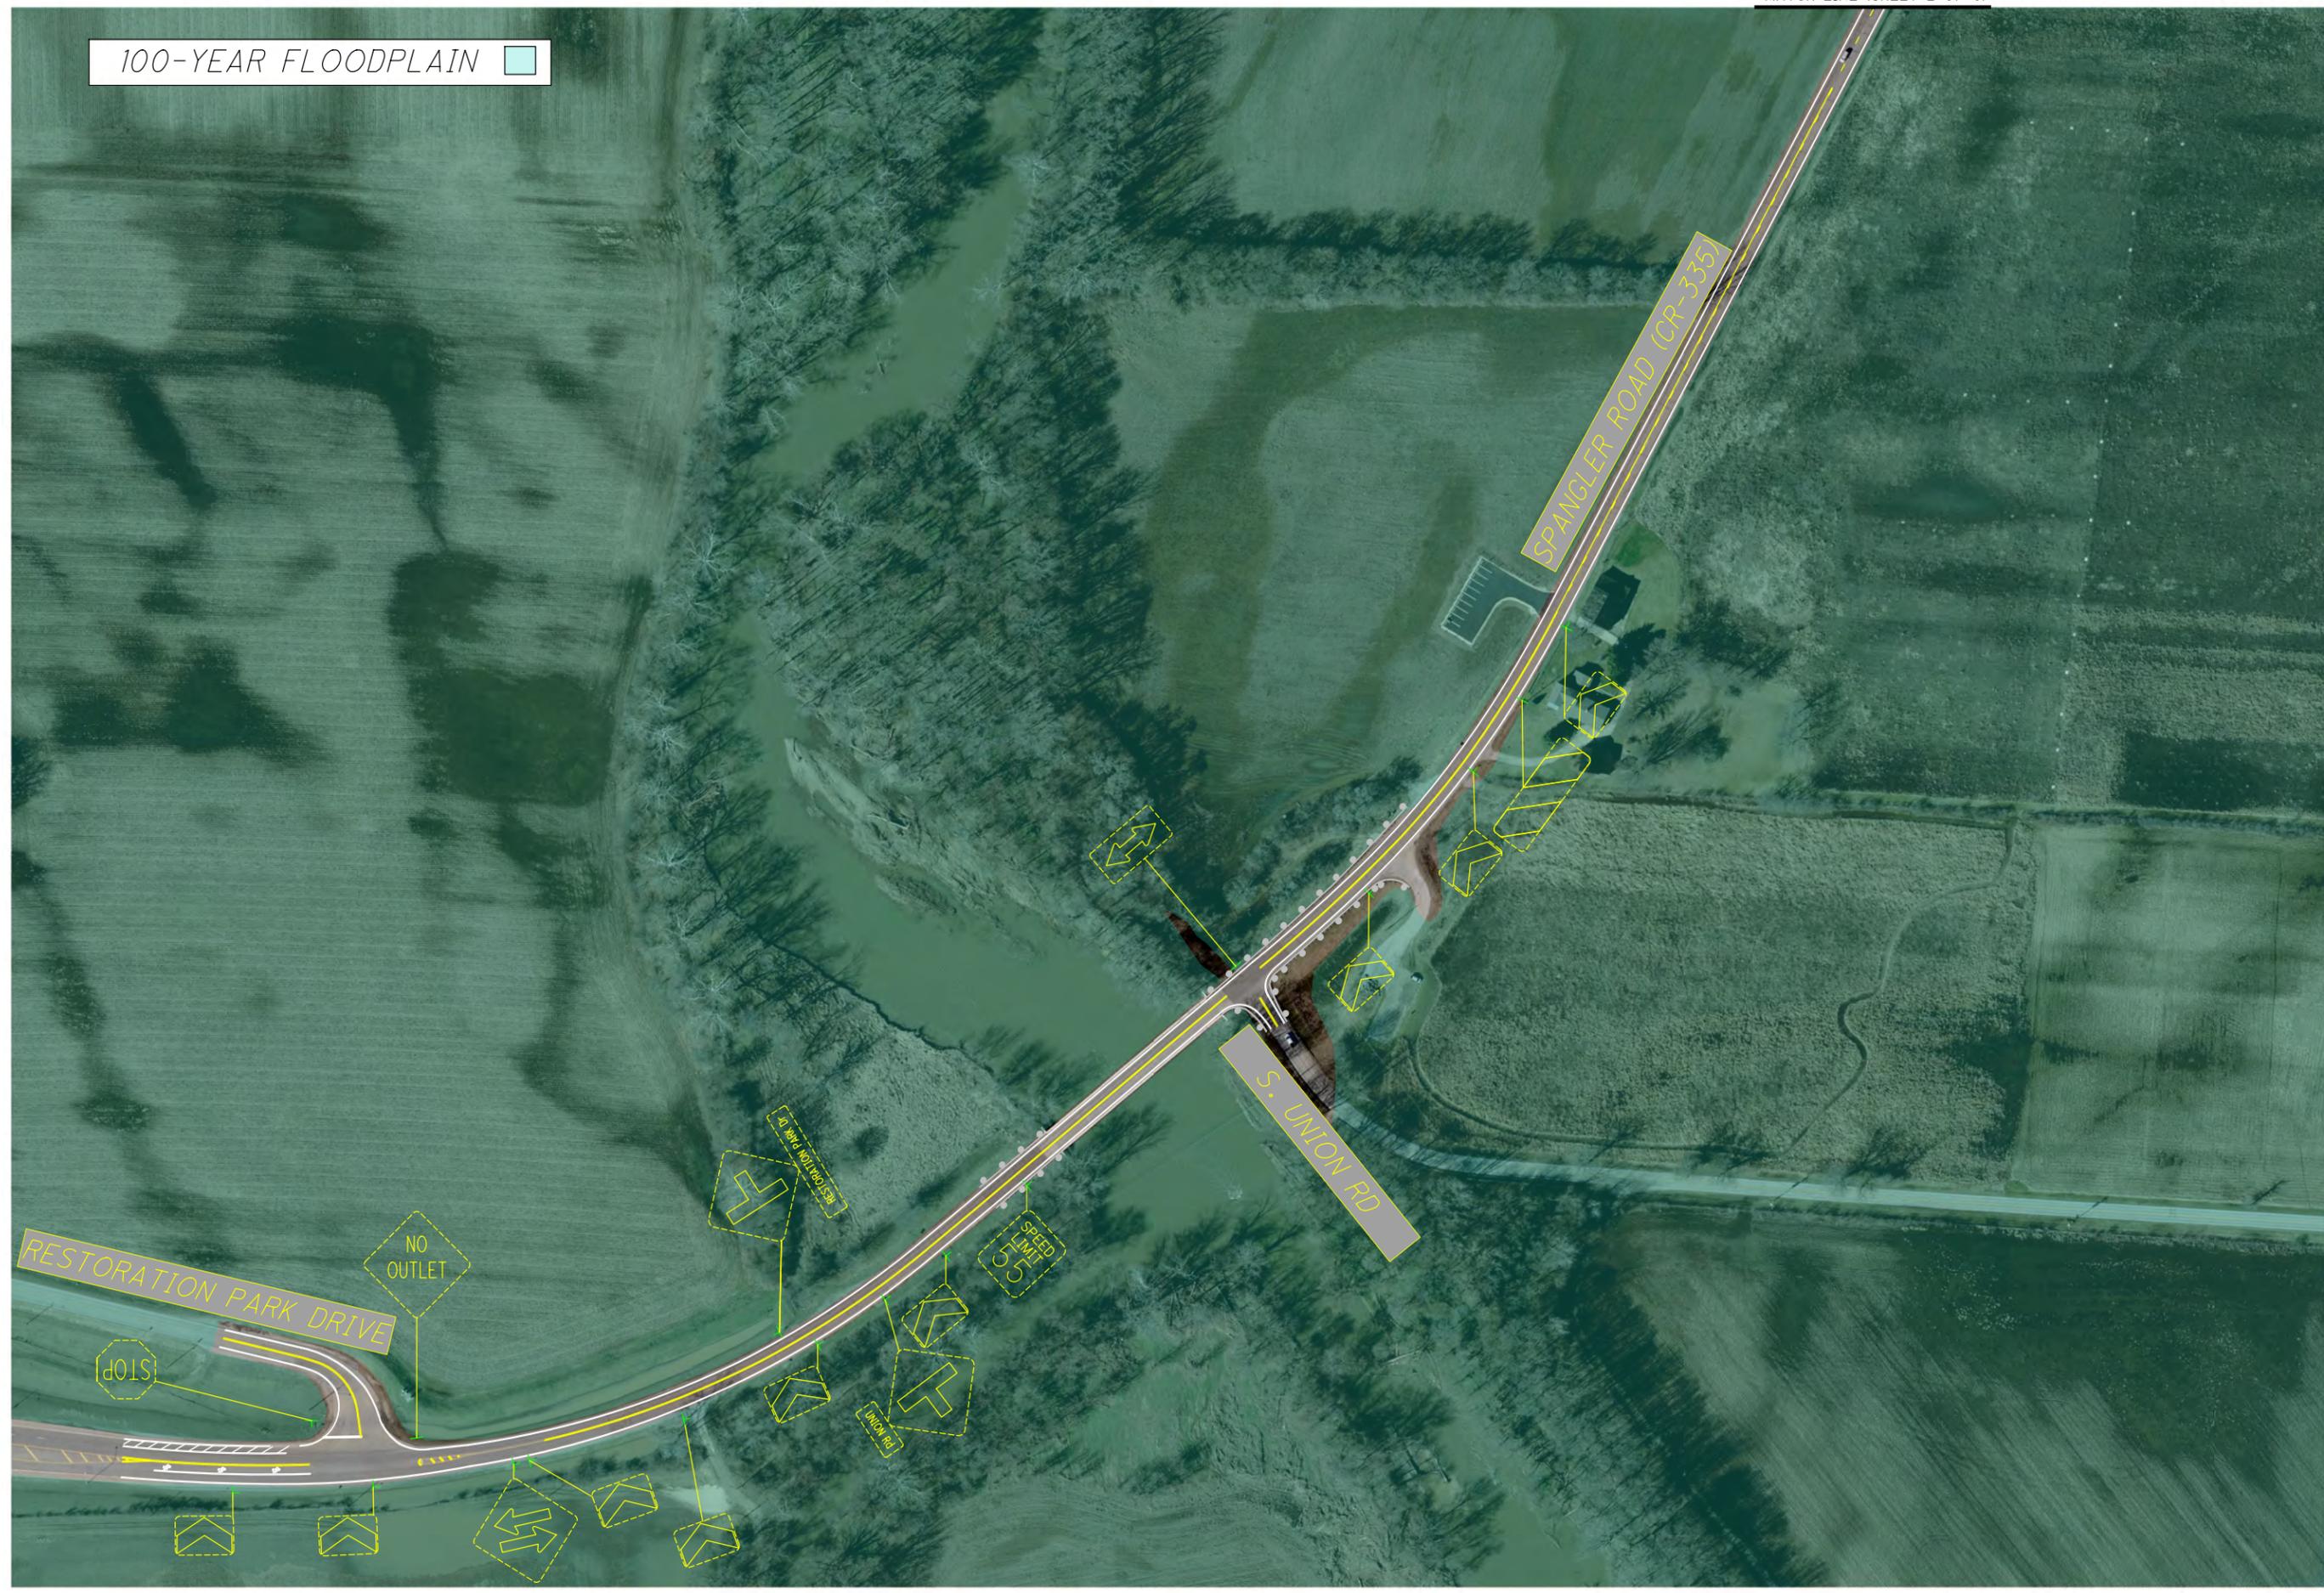
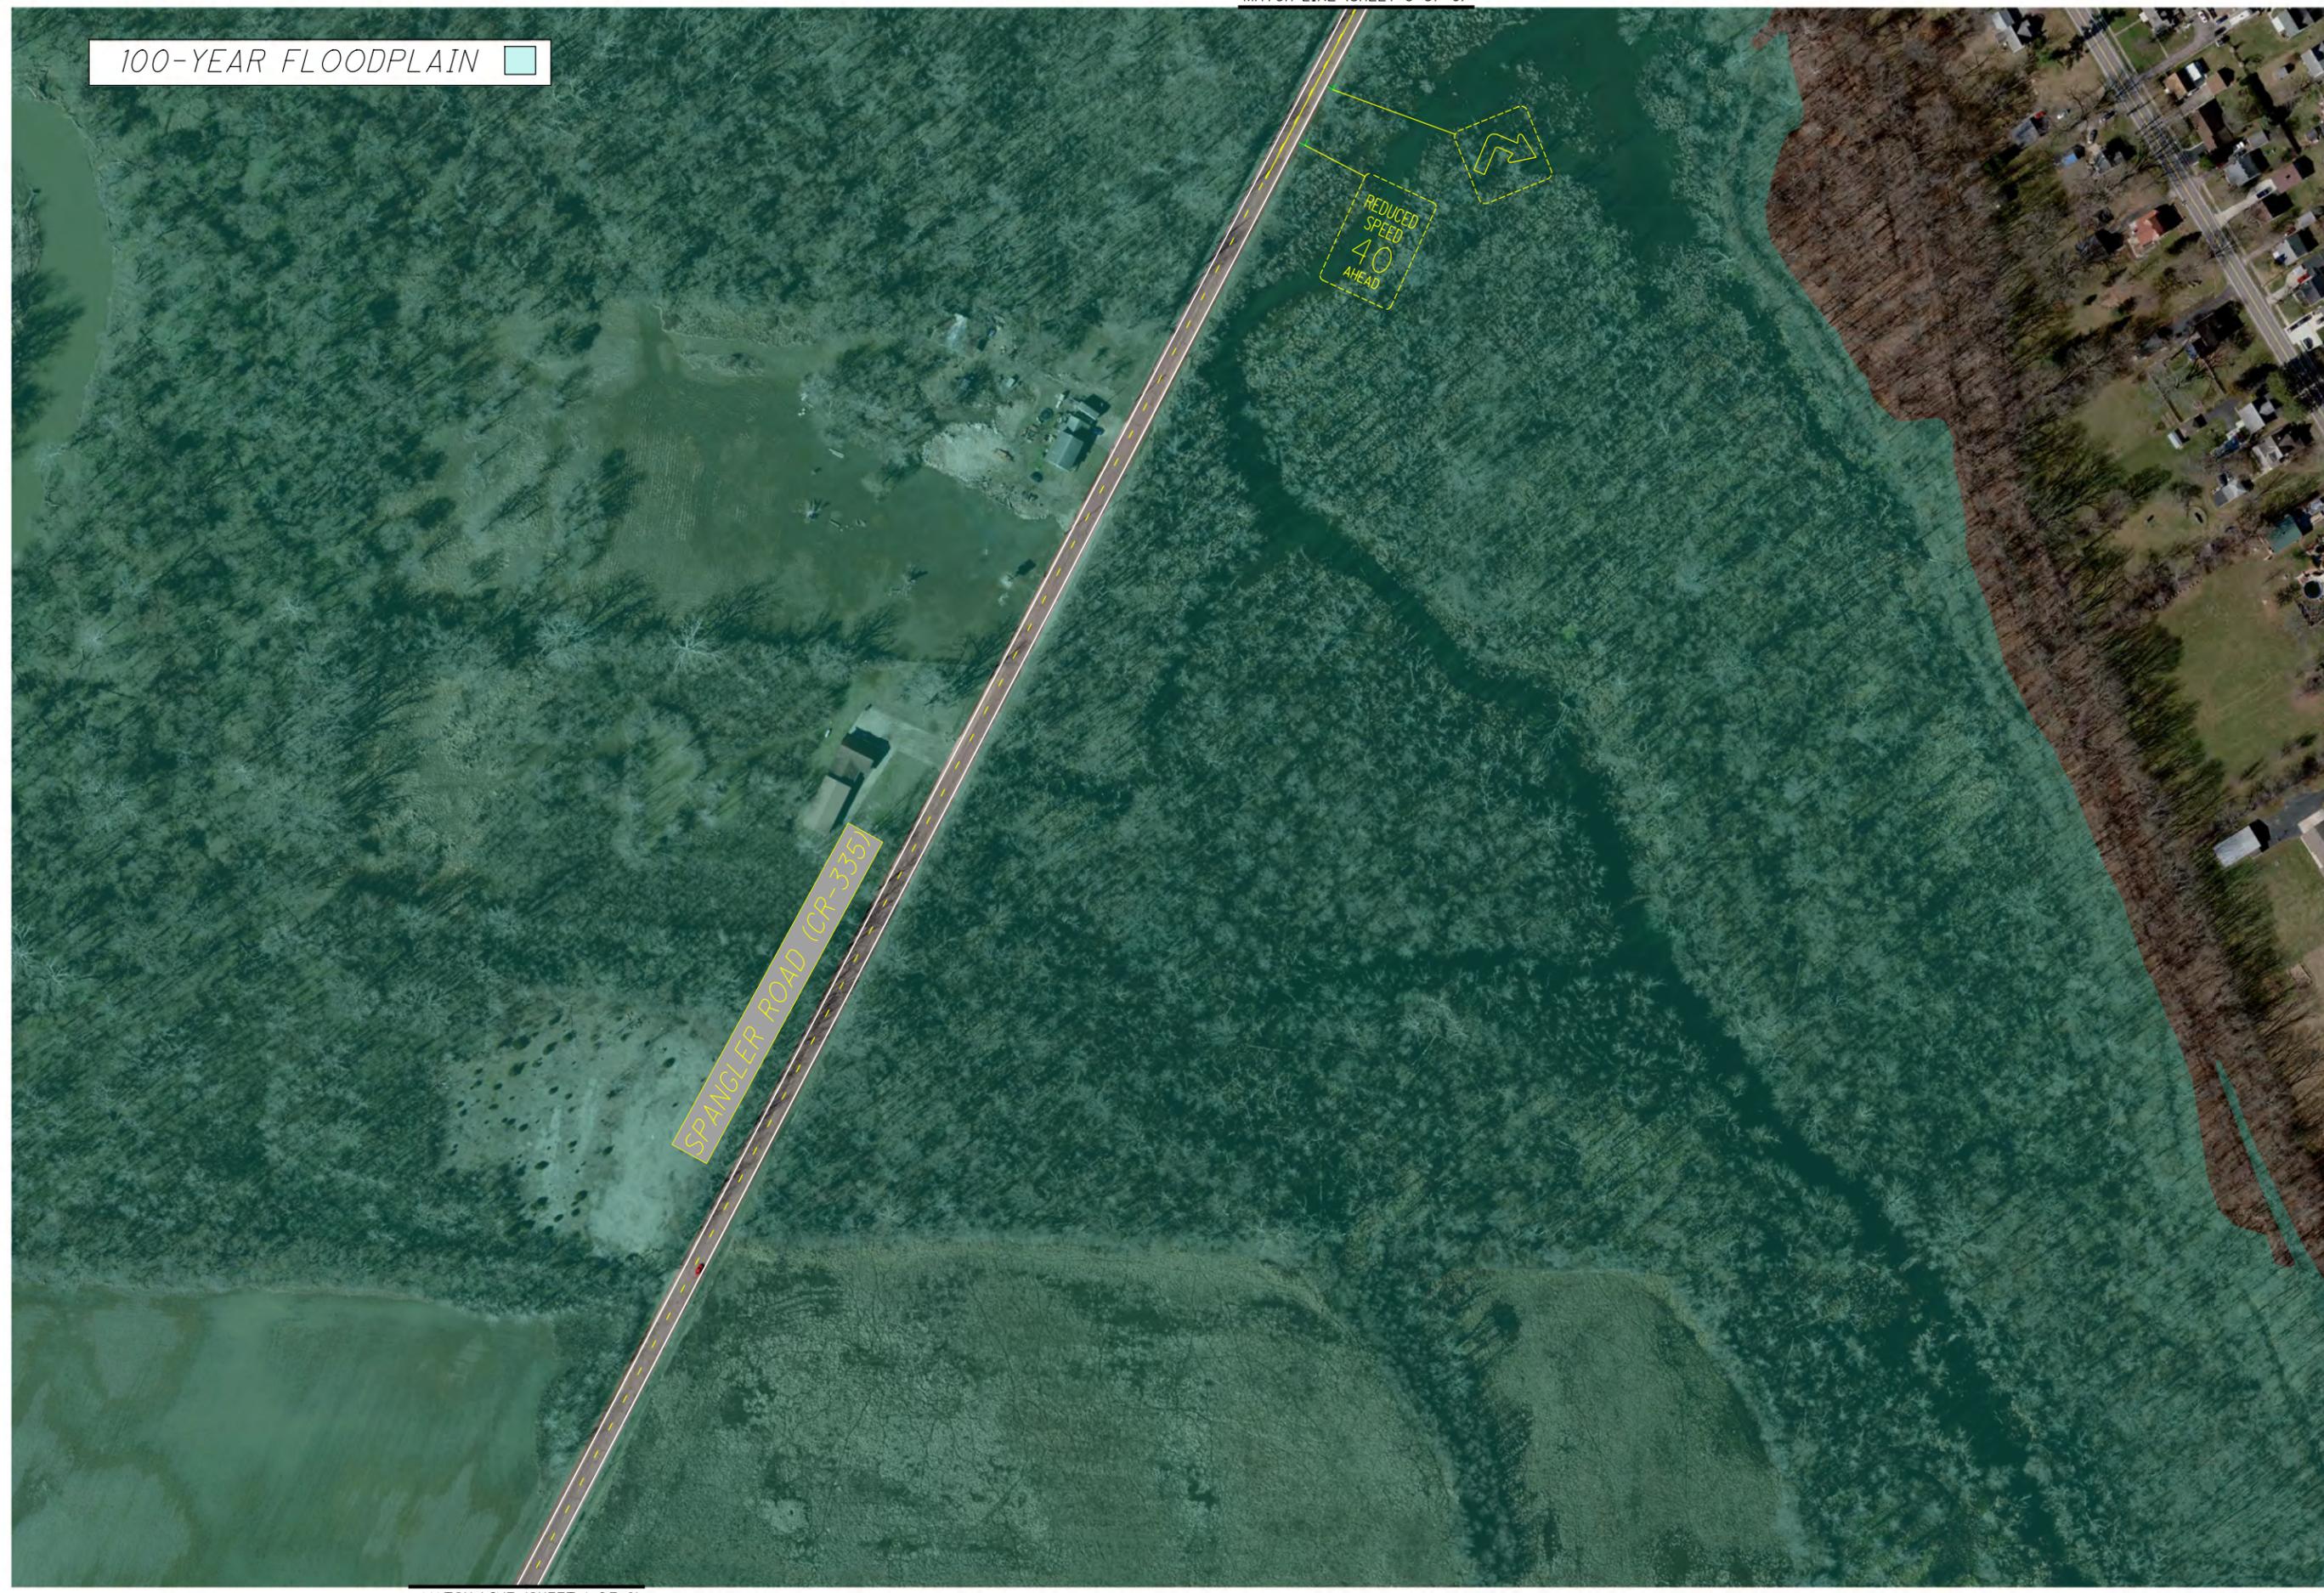
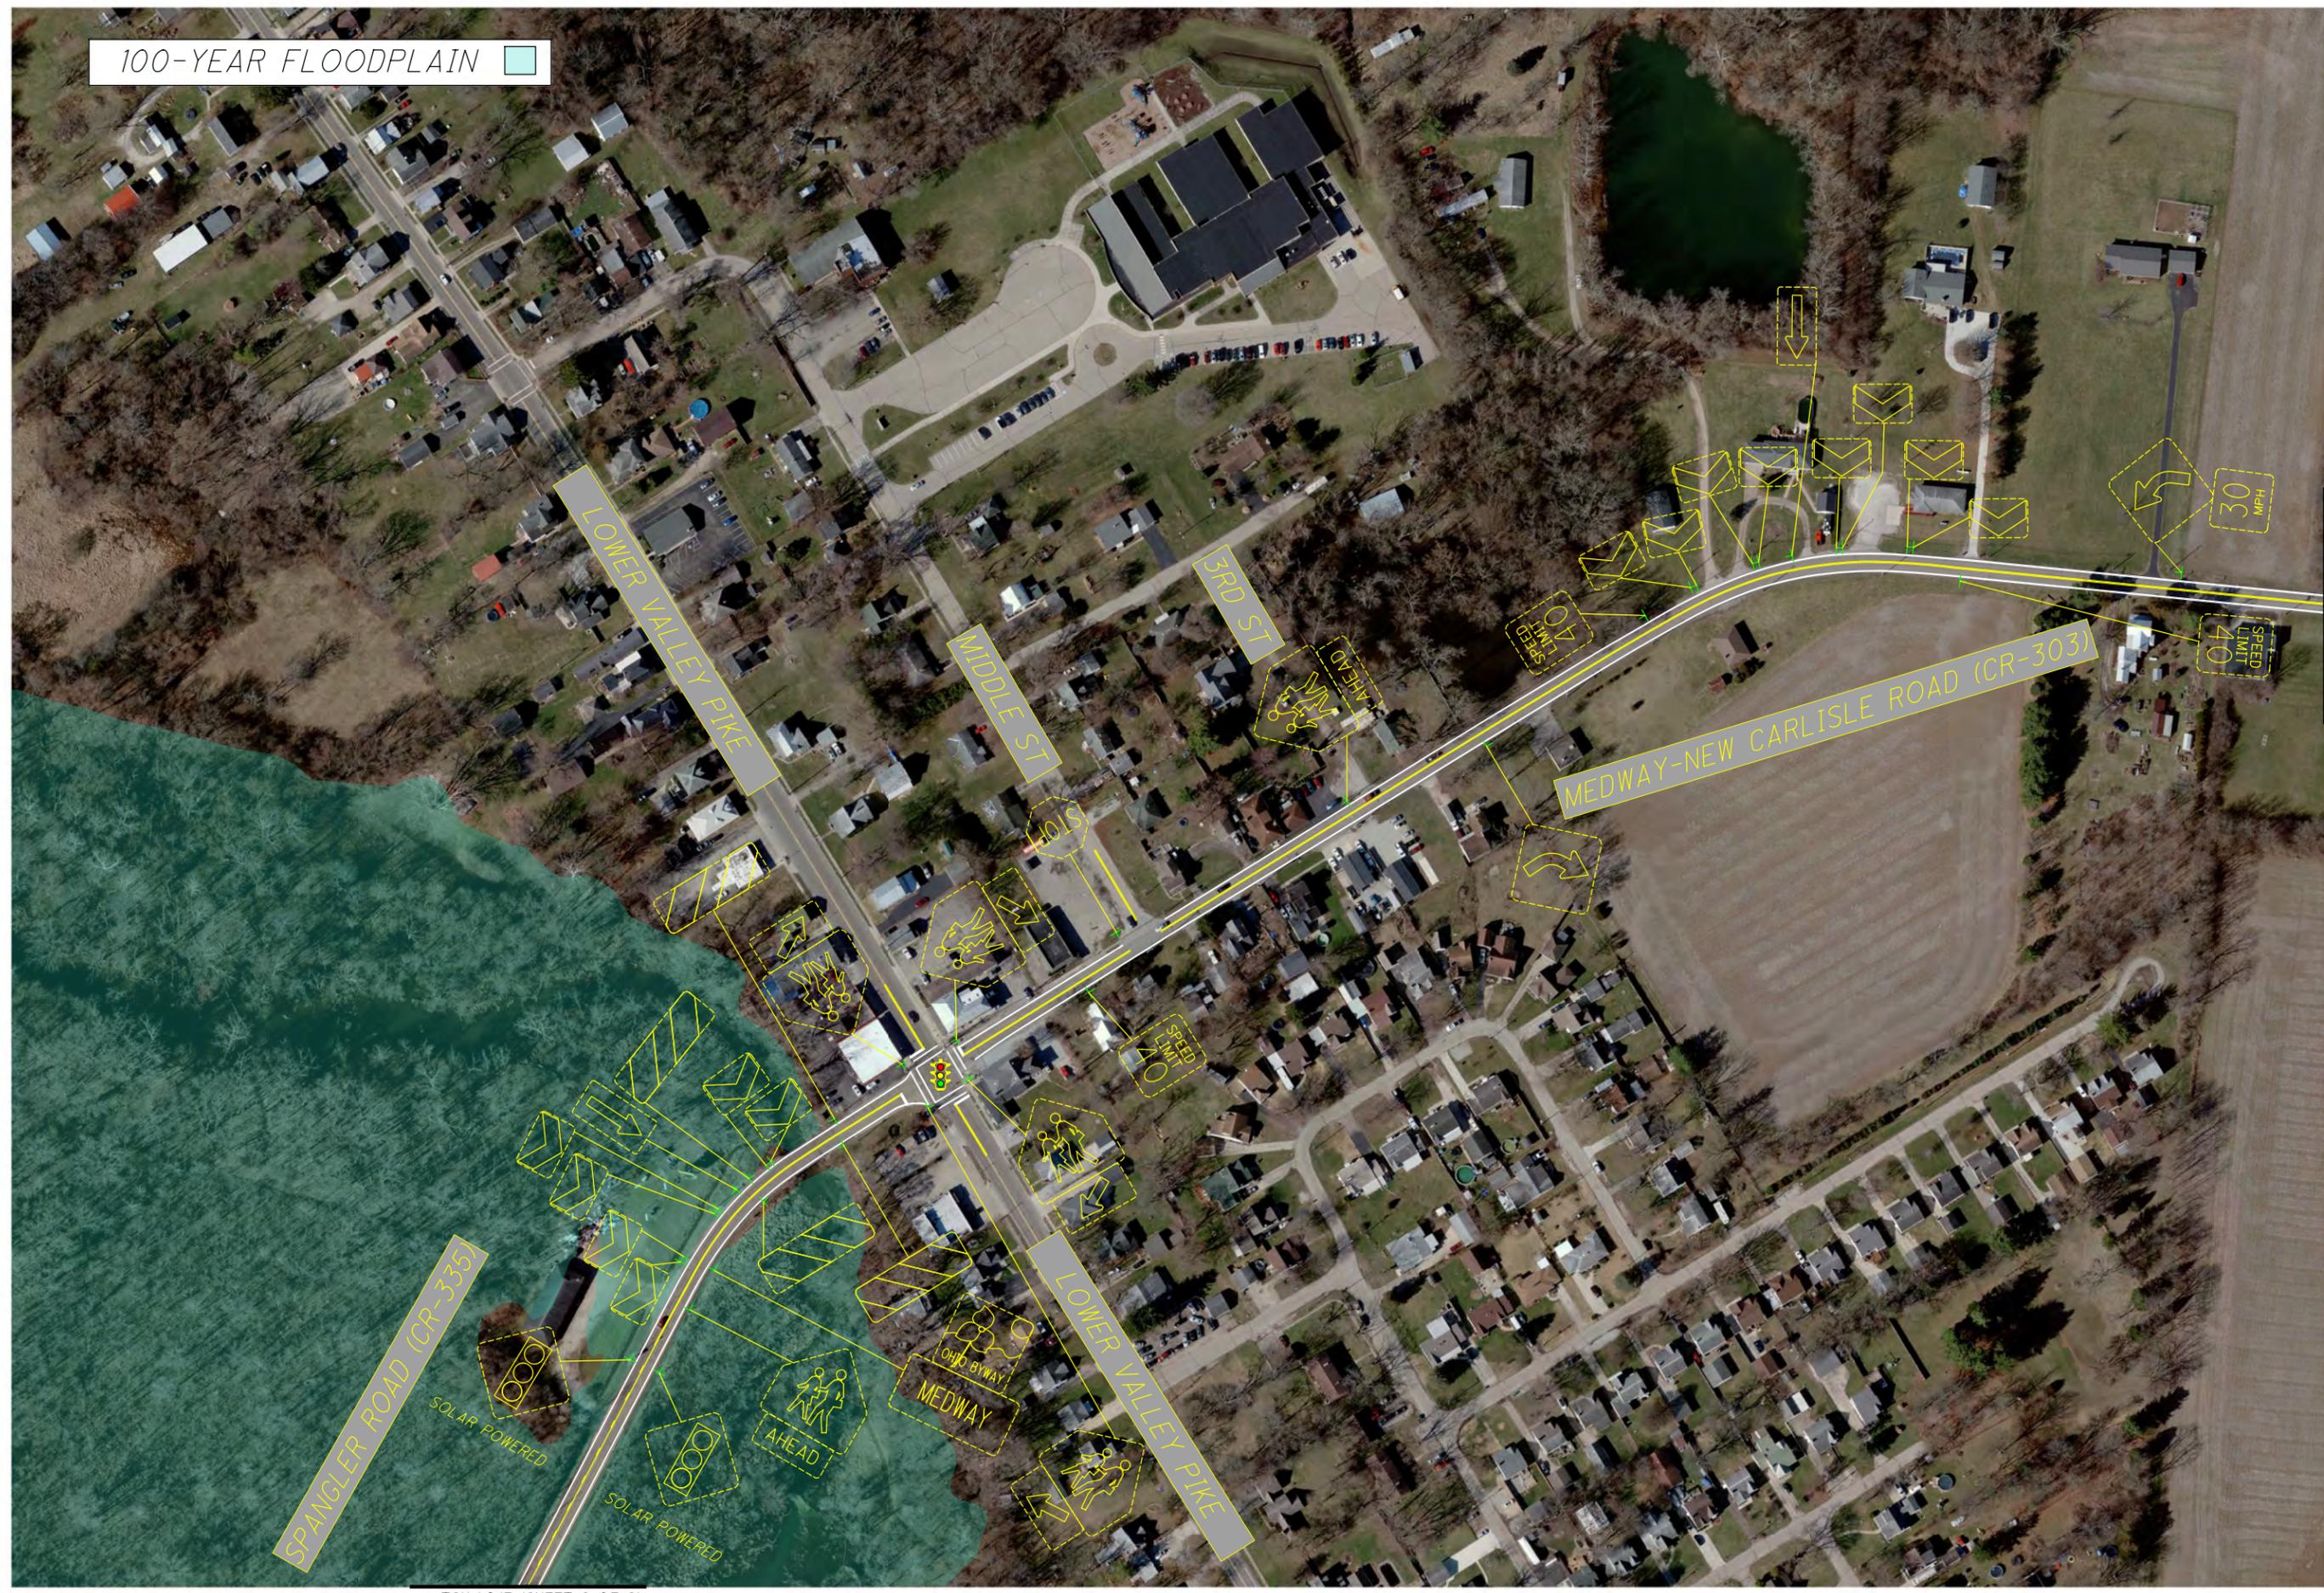
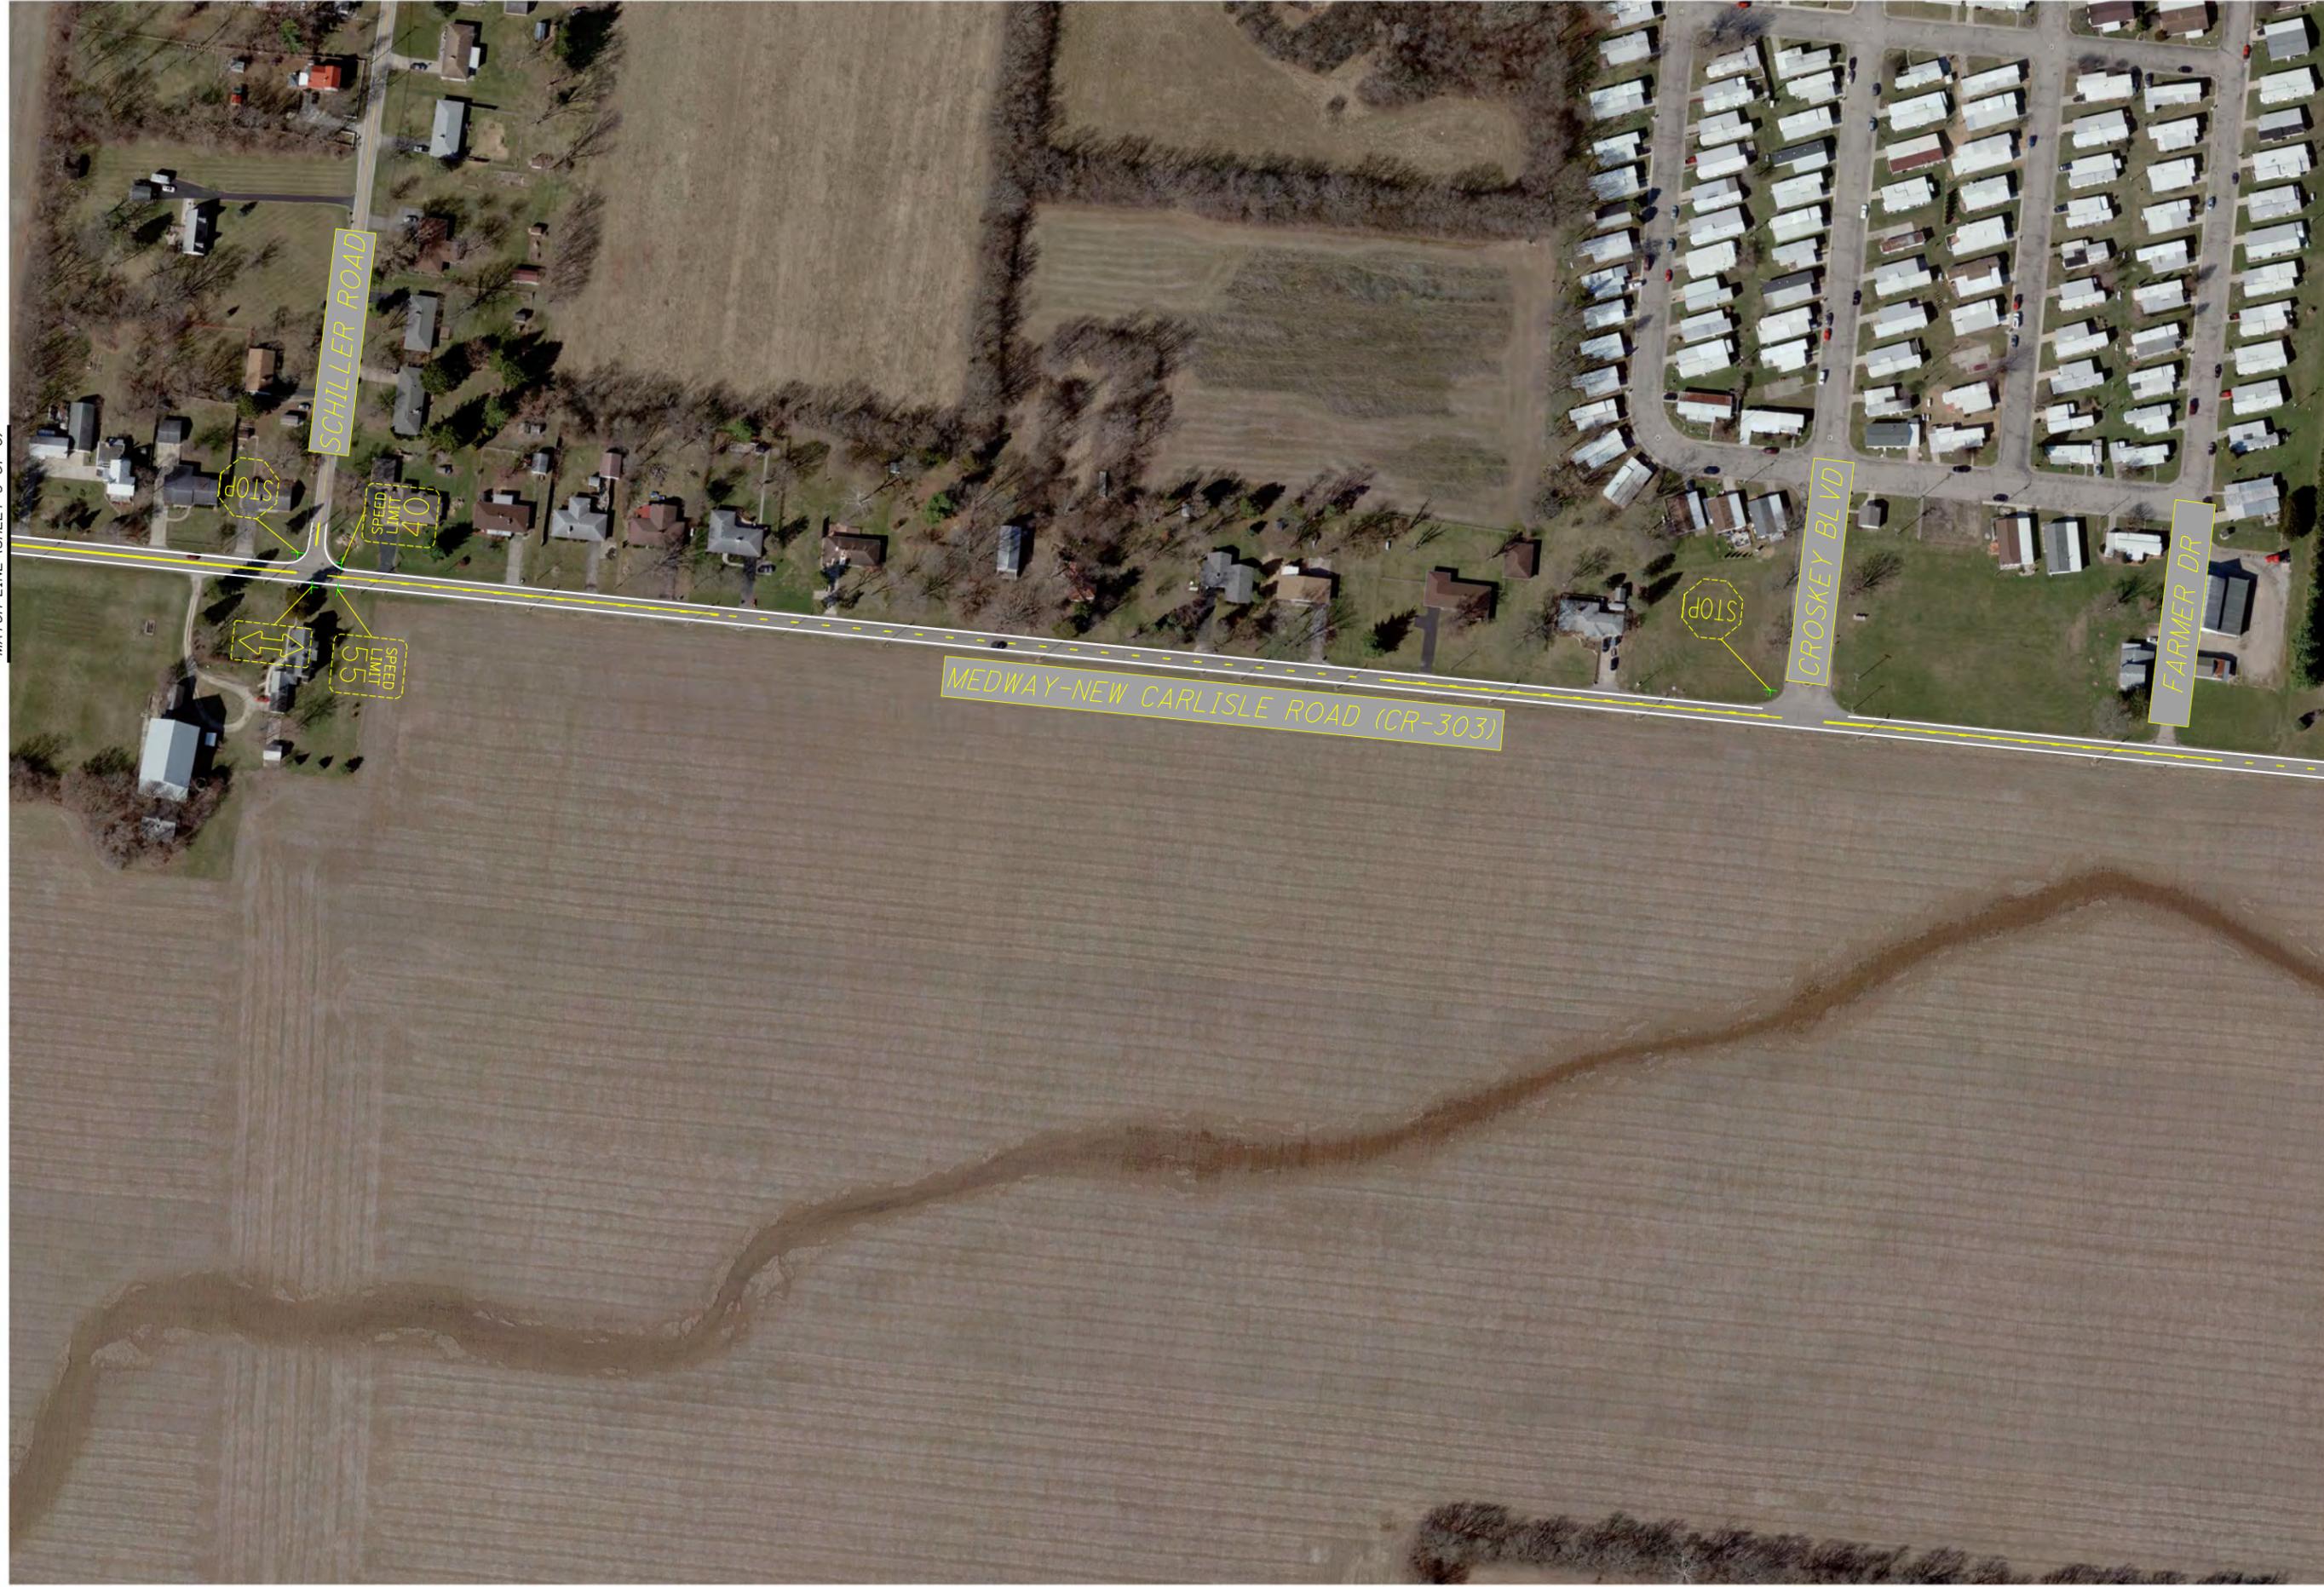
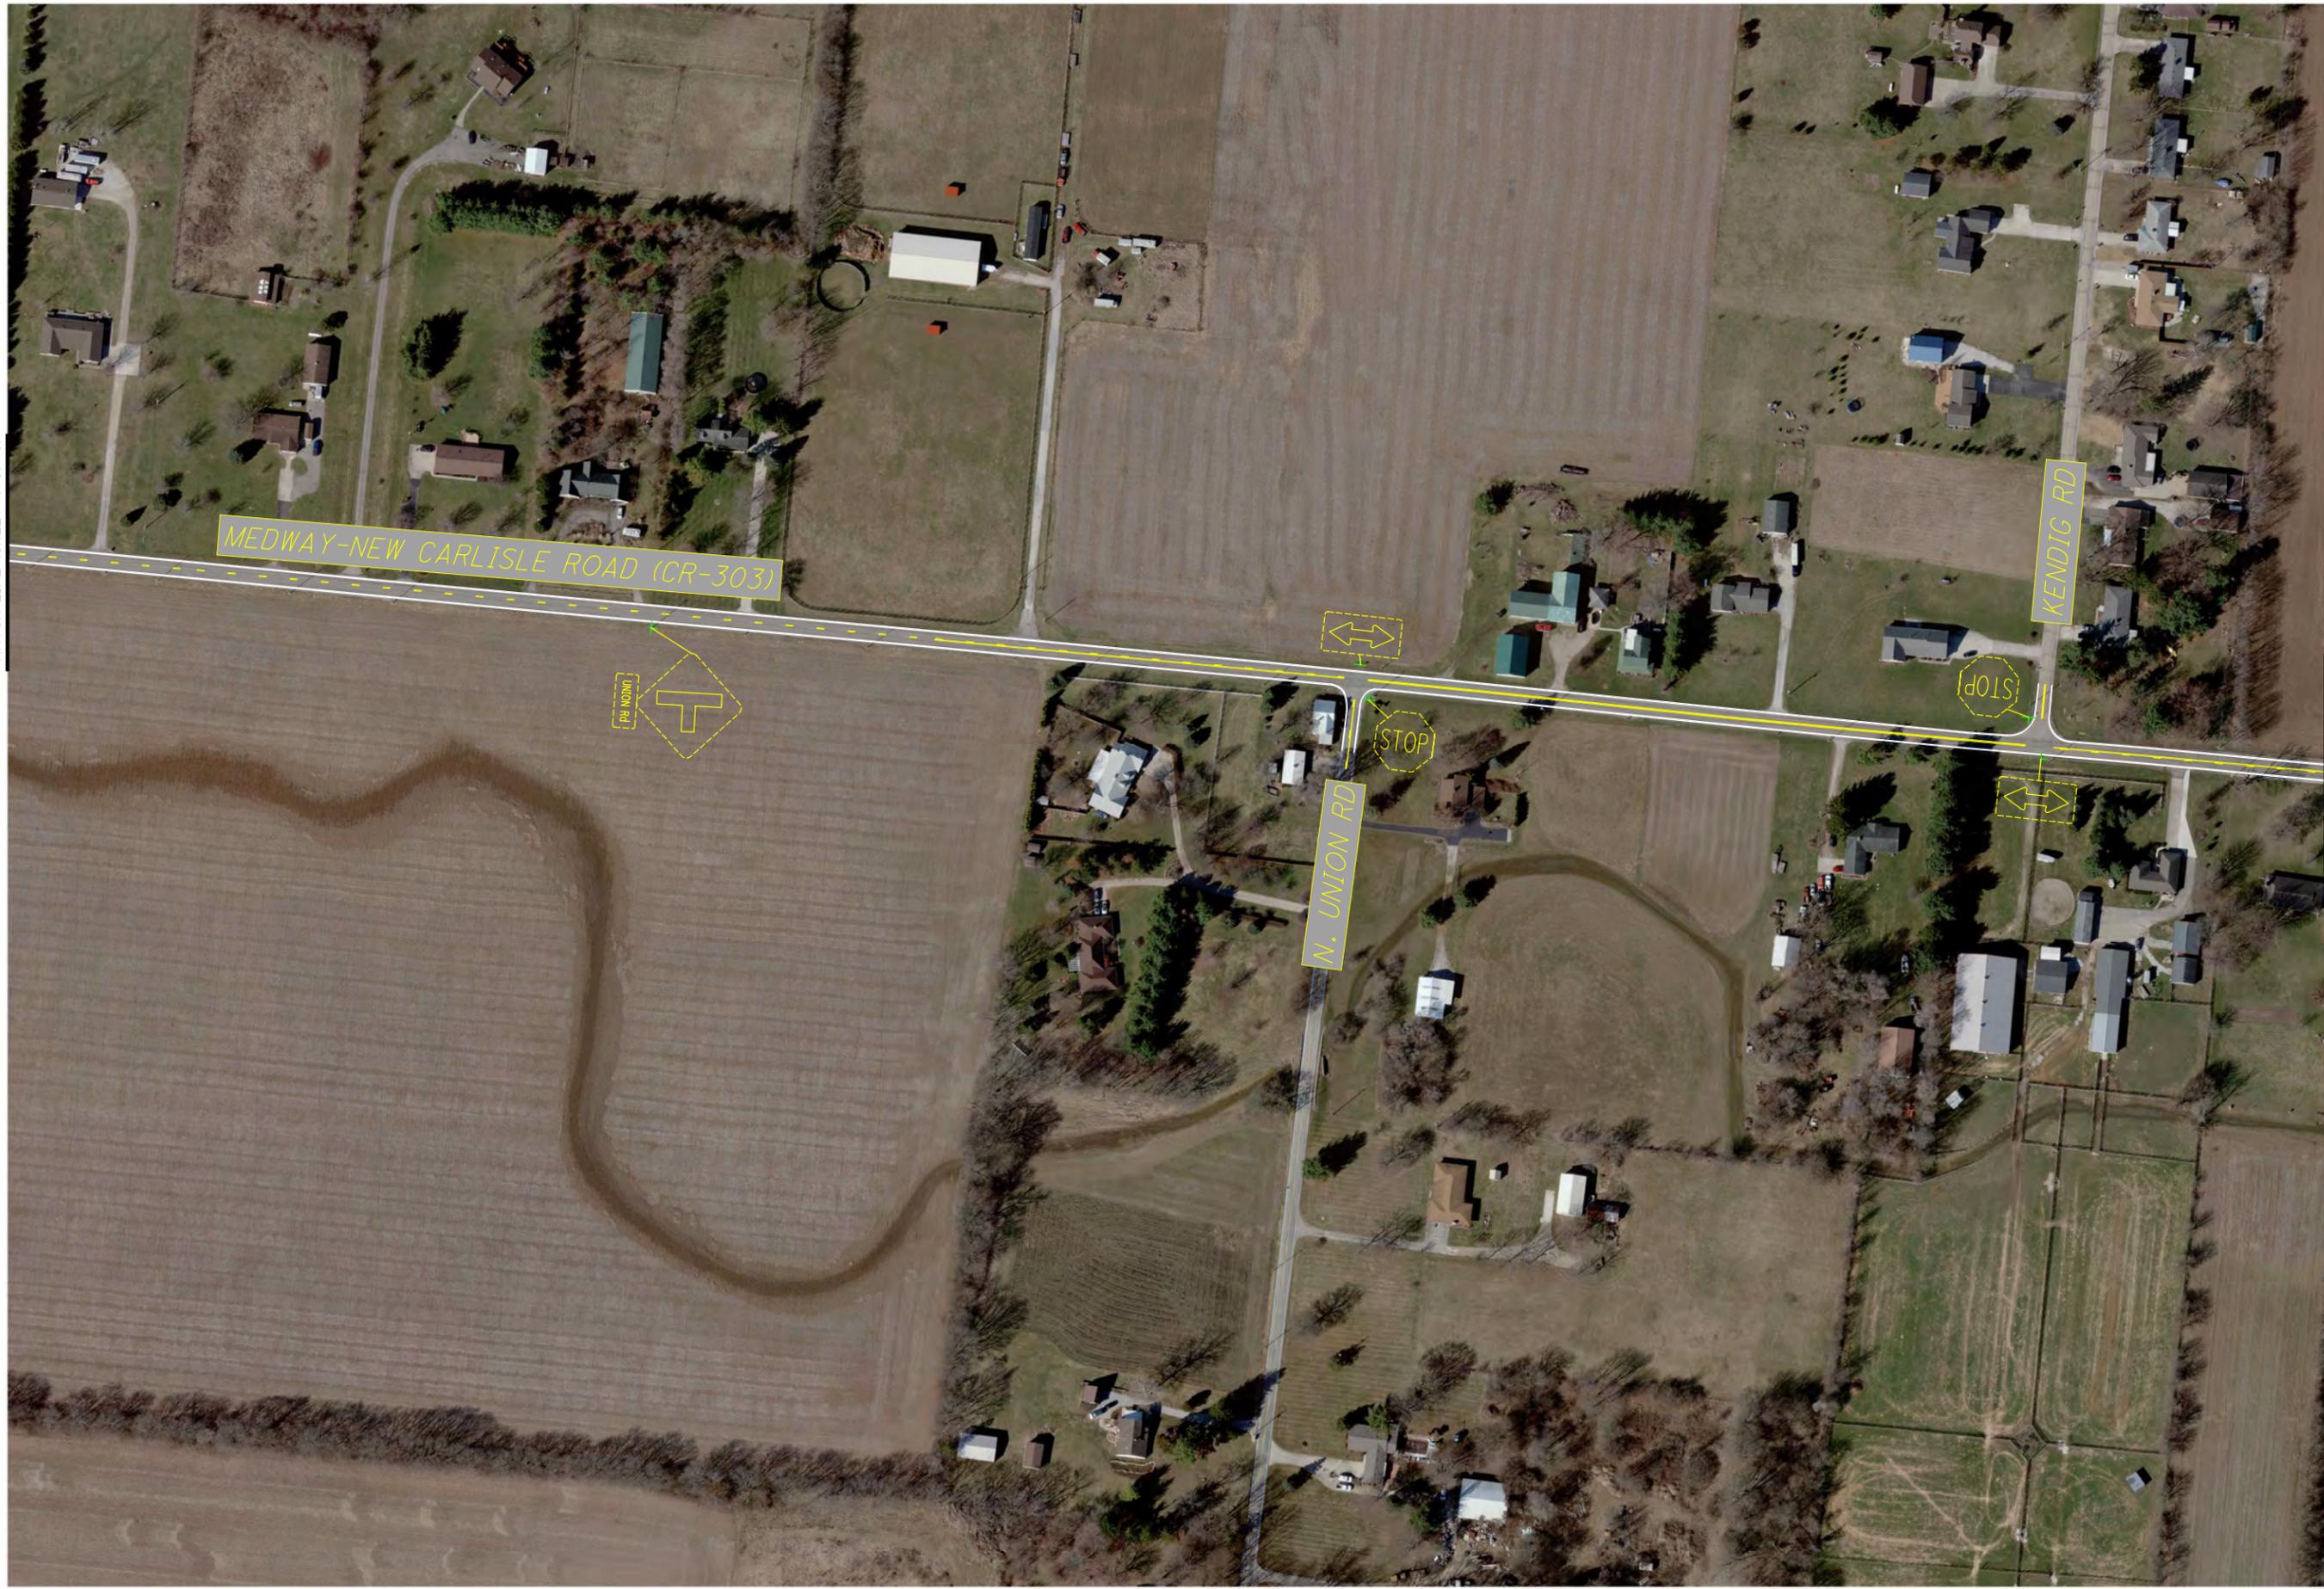
**FIGURE 2.1  
EXISTING CONDITIONS DIAGRAM**

The existing conditions of the CR335/CR303 corridor are displayed on Figure 3.1 (Existing Conditions Diagram). Detailed descriptions of subsections of the corridor are discussed in Section 3.3.

Physical conditions of the CR335/CR303 corridor are illustrated in Figure 3.1. All side streets intersecting CR335/CR303 are under two-way stop control, except for the two intersections of Main Street and that of US40 (National Road) which are both signalized intersections. Land uses along the corridor are primarily residential, farmland, and small community areas. Detailed information regarding project corridor intersections/segments is provided in the following sections.
