# CR335/CR303 SAFETY STUDY

CR335 (SPANGLER RD.) /  
CR303 (MEDWAY-NEW CARLISLE RD.)  
FROM RESTORATION PARK DR.  
TO US40 (W. NATIONAL RD.)

PREPARED FOR:  
CLARK COUNTY ENGINEER  
4075 LAYBOURNE RD.  
SPRINGFIELD, OHIO 45505  
AUGUST 2020

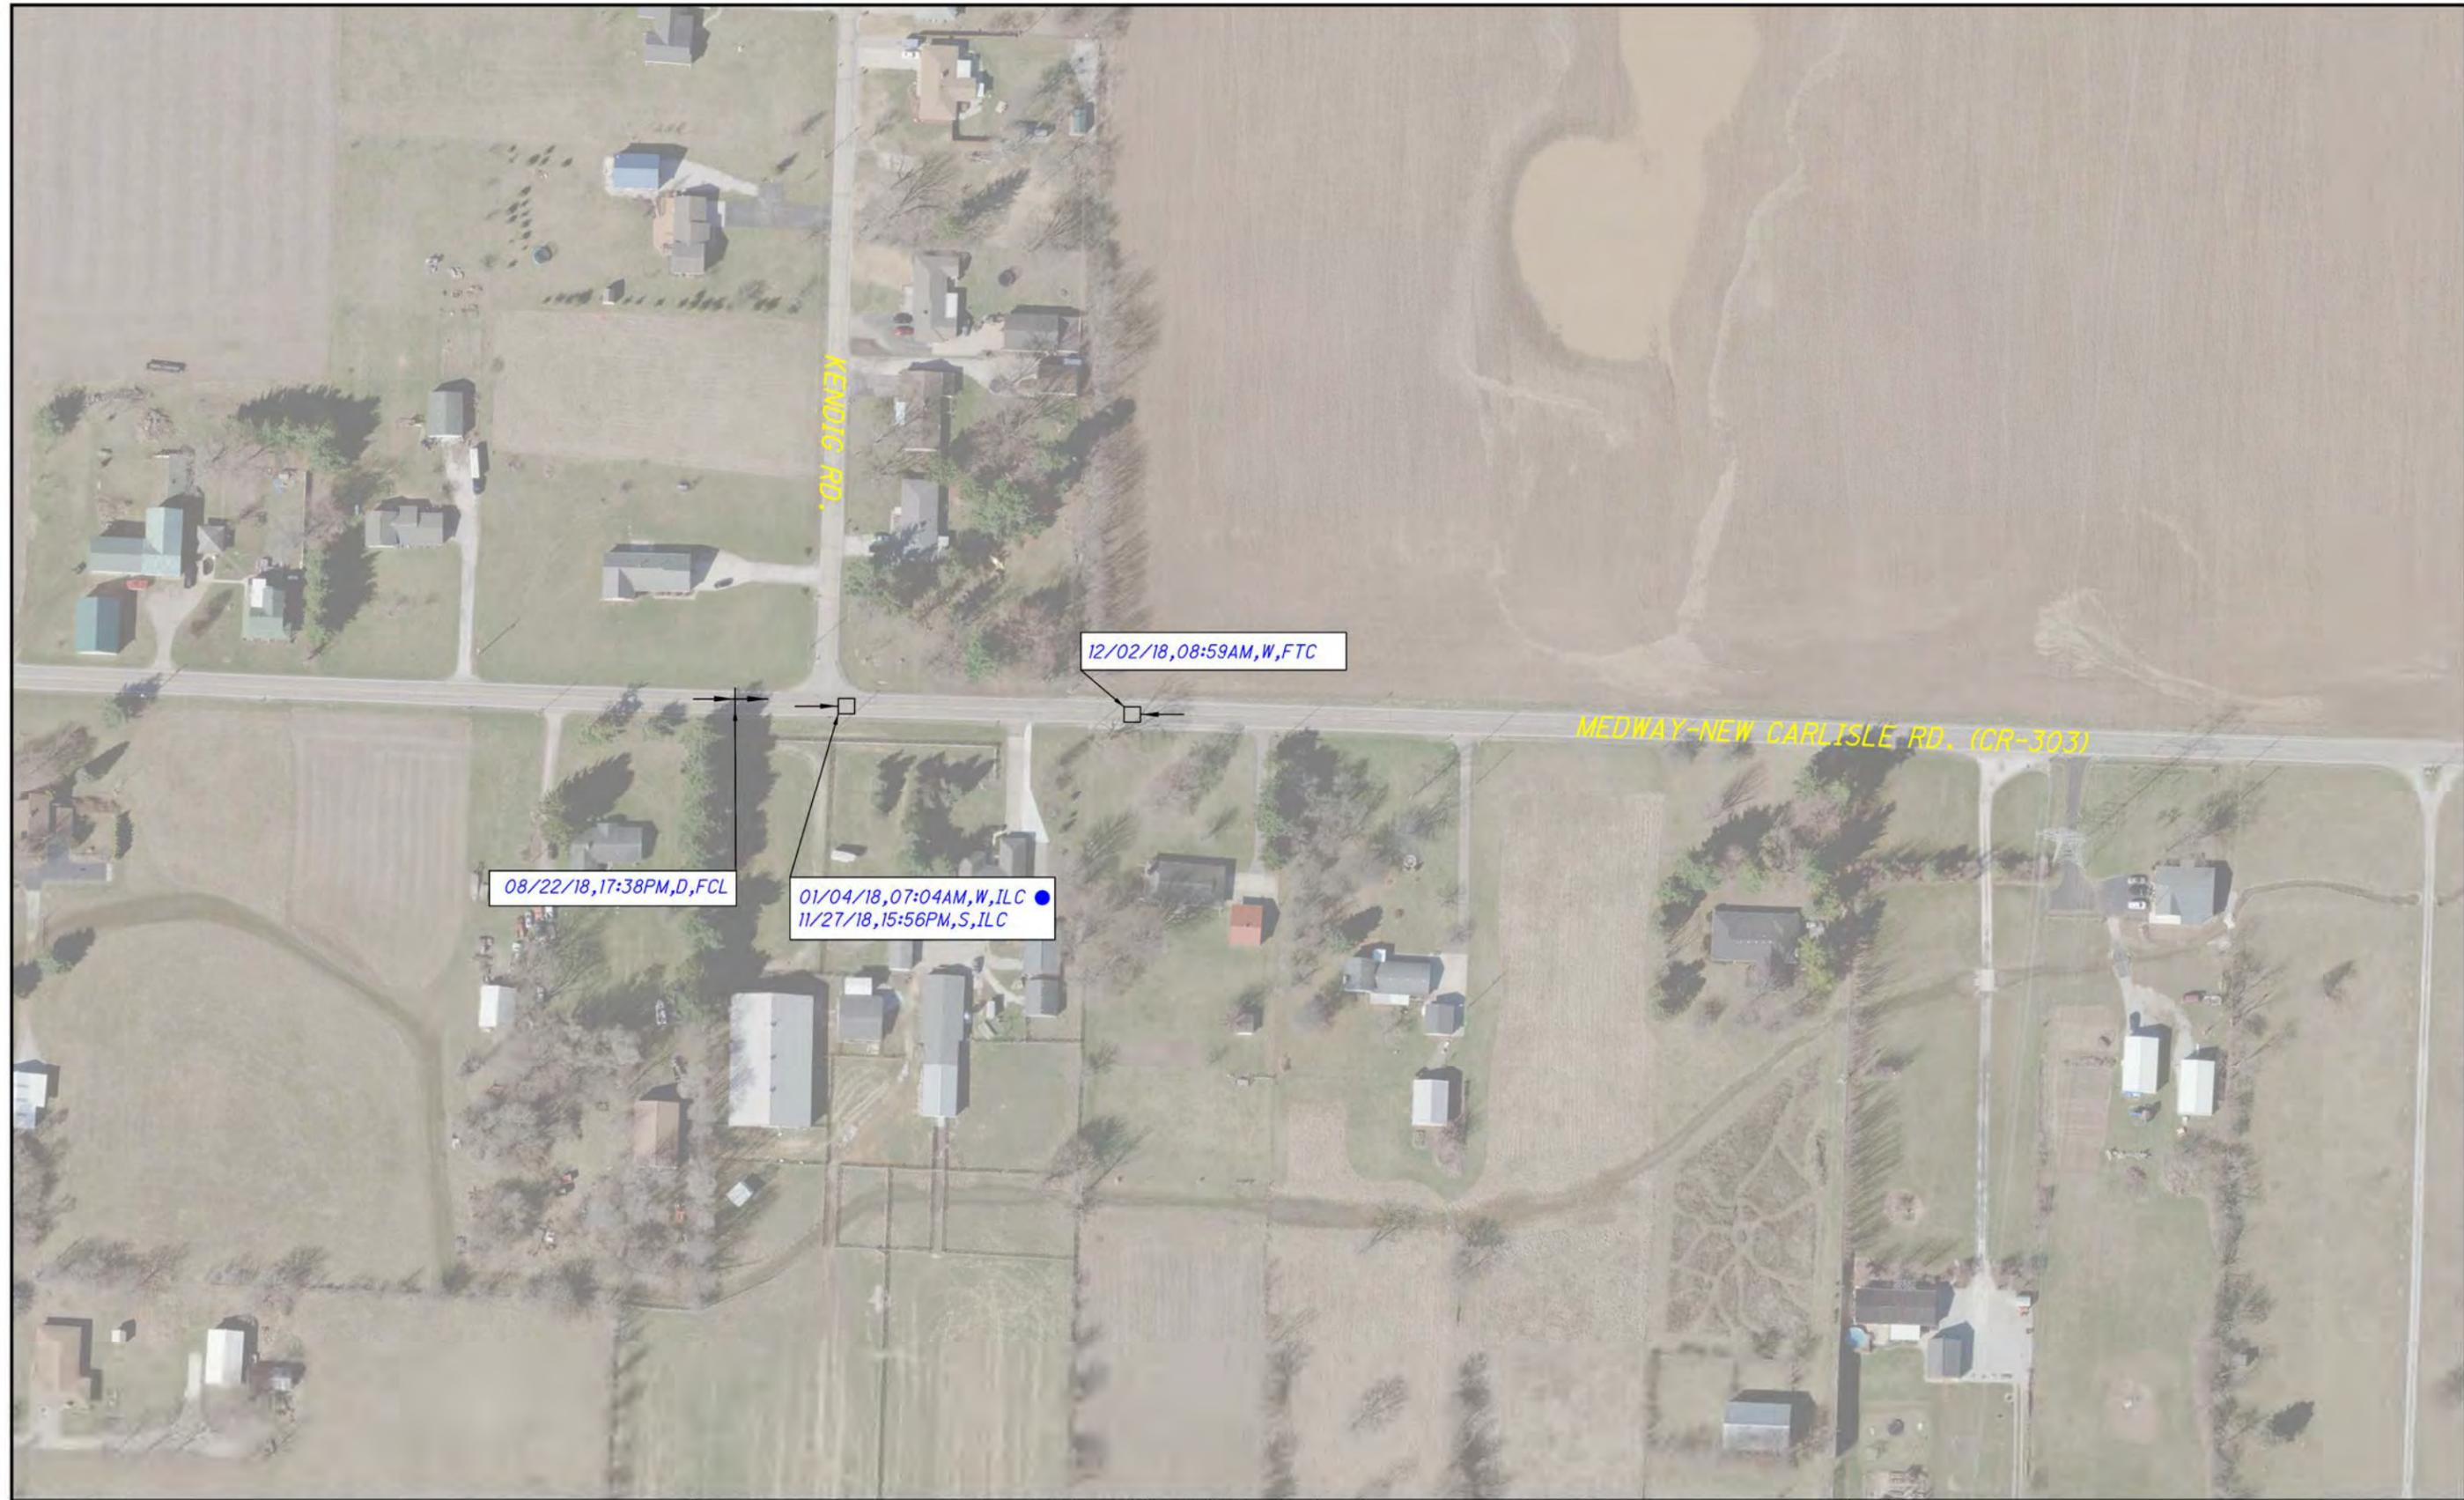
FIGURE 3.1  
COLLISION DIAGRAM

A set of collision diagrams were developed (Figure 3.1) for the corridor based on a review of OH-1 Crash Reports obtained from ODOT. A review of collision diagrams revealed that the majority of crashes occurred on the 1.1-mile section of CR335 (Spangler Road) from Restoration Park Drive to Main Street in Medway as this section accounted for 57% (32 crashes) of the total 56 crashes and contained 73% (11 crashes) of the 15 fatal/injury crashes within the study limits. The remaining 2.0-mile section of the corridor study limits on CR303 (Medway-New Carlisle Road) contained 43% (24 crashes) of all crashes and 27% (4 crashes) of the fatal/injury crashes. The predominant crash type of the CR335 (Spangler Road) section included 18 Fixed Object crashes (56% of crashes on this section) that resulted in 7 injury crashes and one (1) fatal crash. The majority of these Fixed Object Crashes involved leaving the roadway and hitting either a utility pole or tree which are typically within 3 to 5 feet of the edge of the roadway that has shoulders of 2-FT or less.

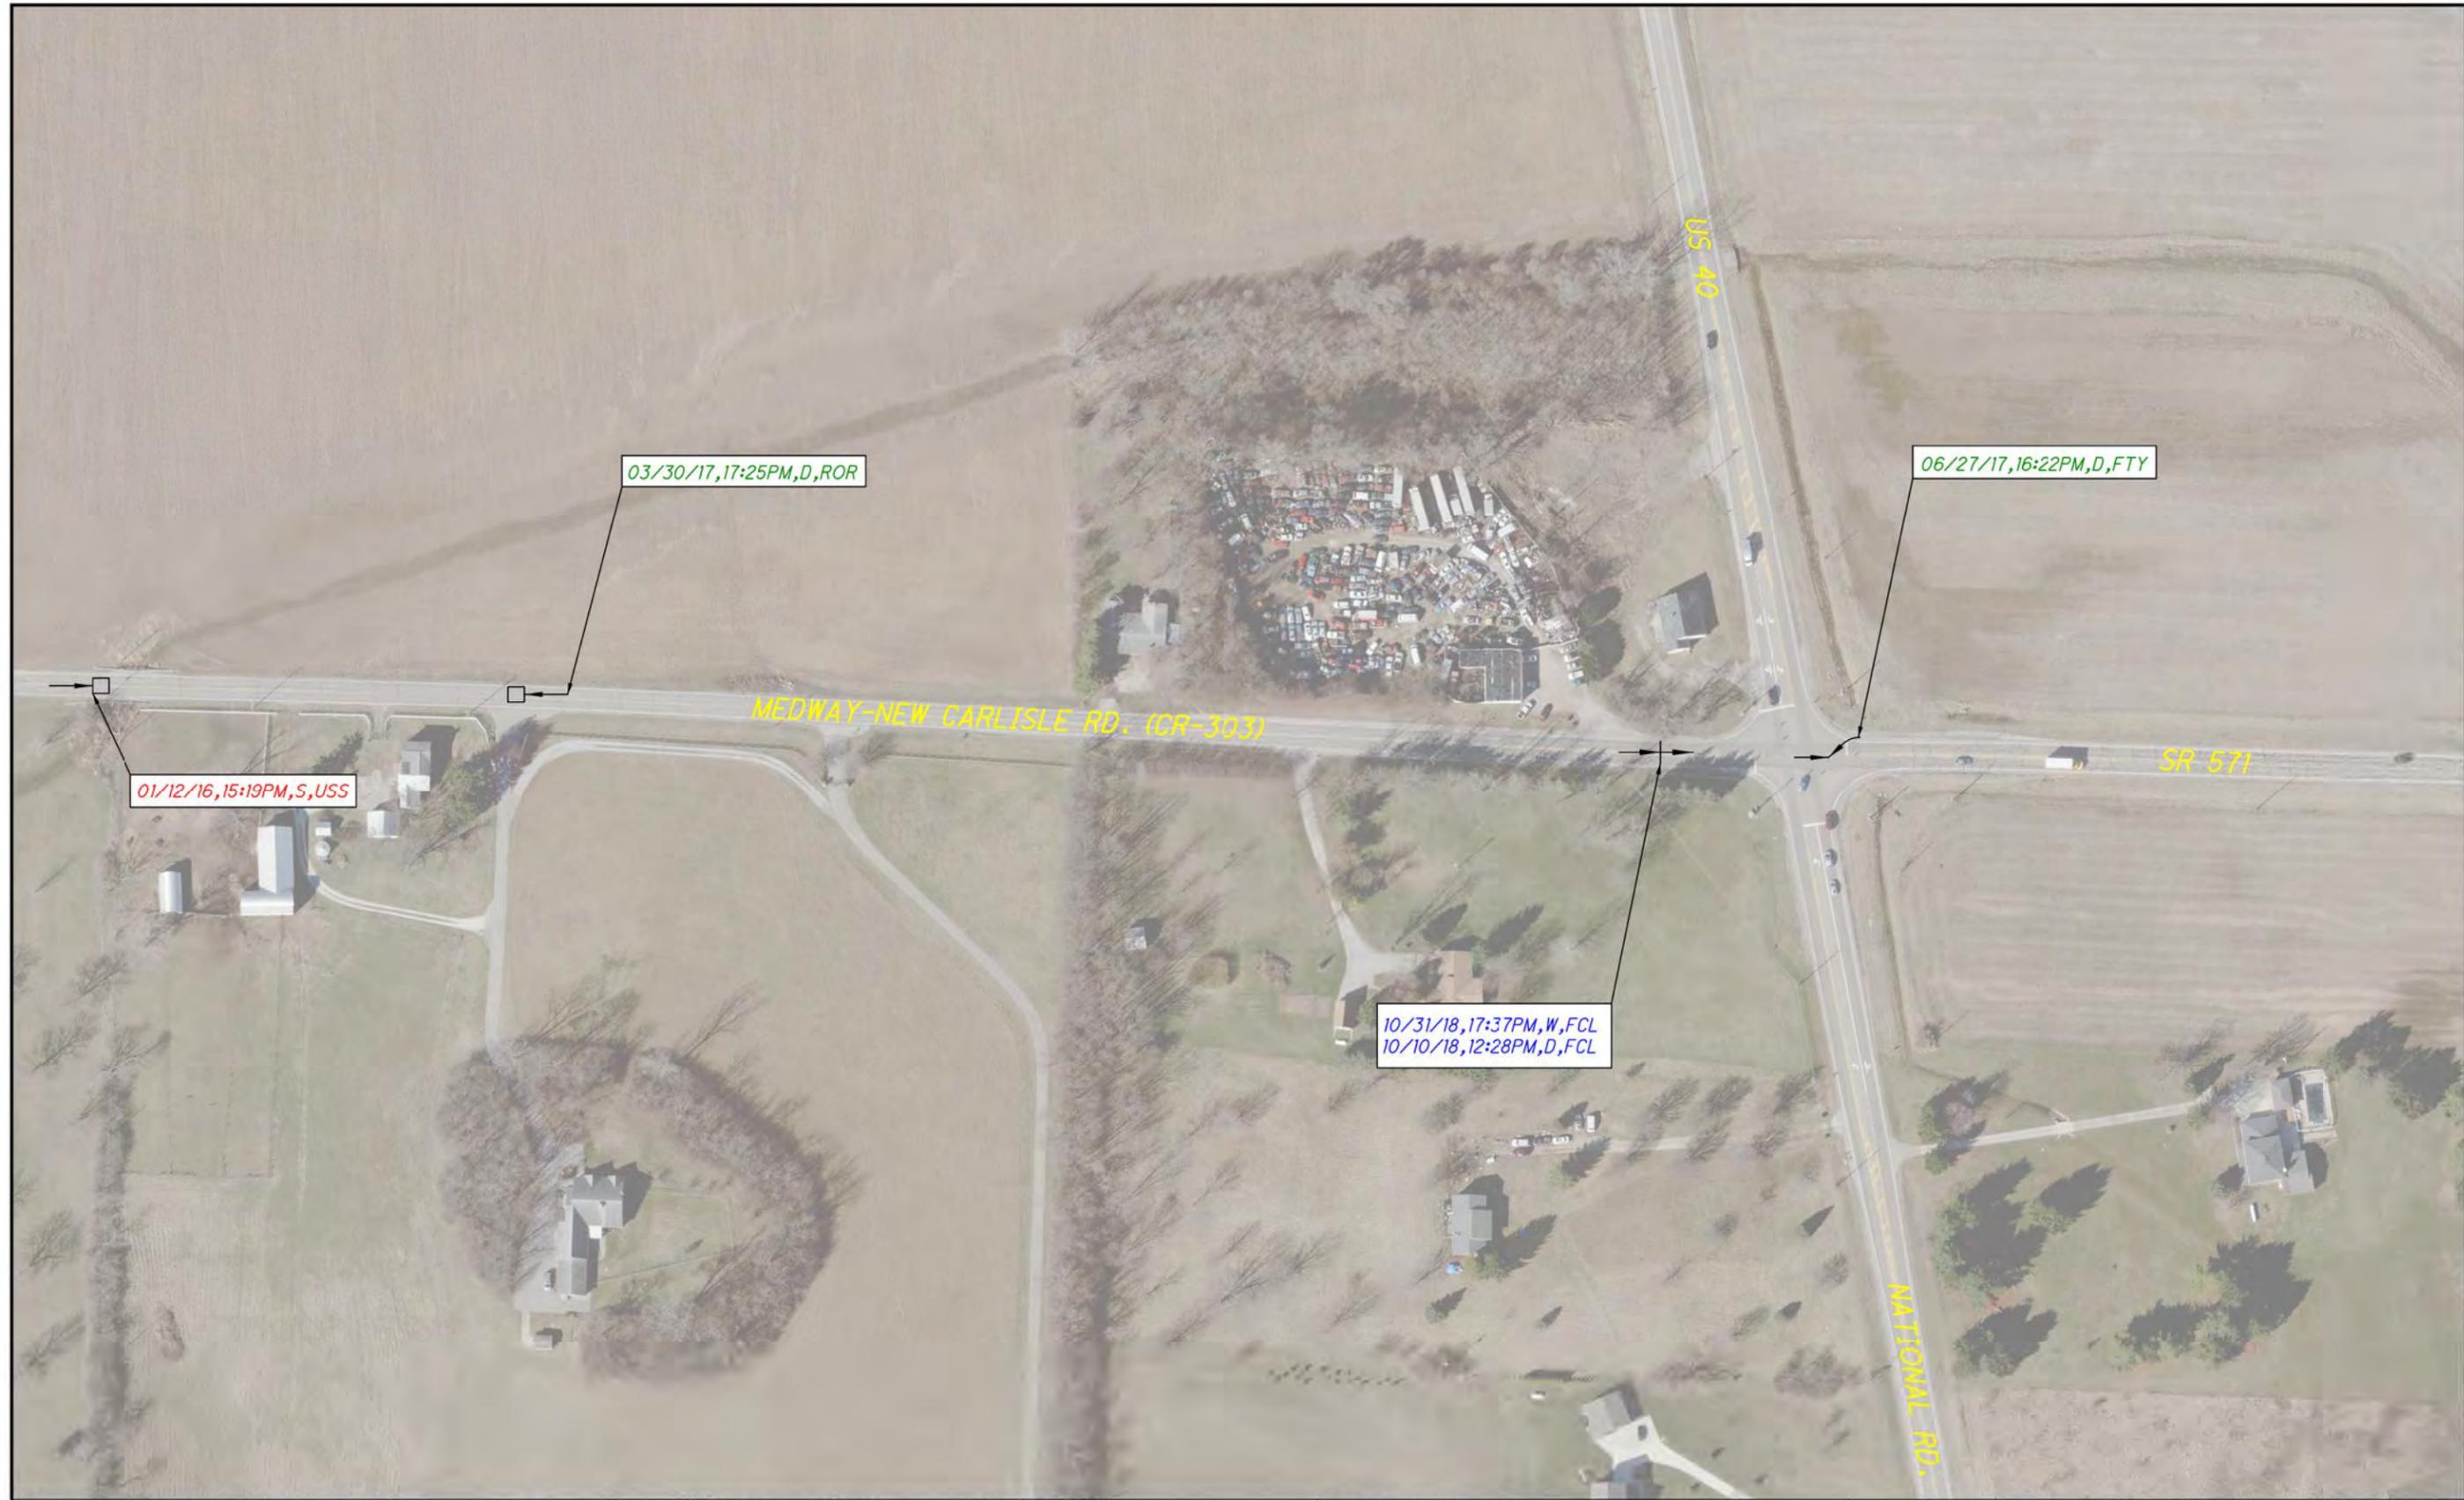
FIGURE 3.1  
COLLISION DIAGRAM

CRASH TYPES:			CONTRIBUTING FACTORS:			ROAD CONDITION:		CRASH DESCRIPTION		PAGE SUMMARY	
	REAR-END		BACKING		OTHER	D = DRY	DATE, TIME, ROAD CONDITION, CONTRIBUTING FACTOR	FREQUENCY	SEVERITY	3	PROPERTY DAMAGE ONLY (PDO)
	TURNING		FIXED OBJECT		PARKED VEHICLE	W = WET					0
	HEAD ON		SIDESWIPE (MEETING)		ANIMAL	I = ICE		0	2017	0	FATAL
	OVERTURNING		SIDESWIPE (PASSING)		BICYCLE	S = SNOW		4	2018	4	TOTAL CRASHES (CURRENT PAGE)
			ANGLE		PEDESTRIAN	U = UNKNOWN

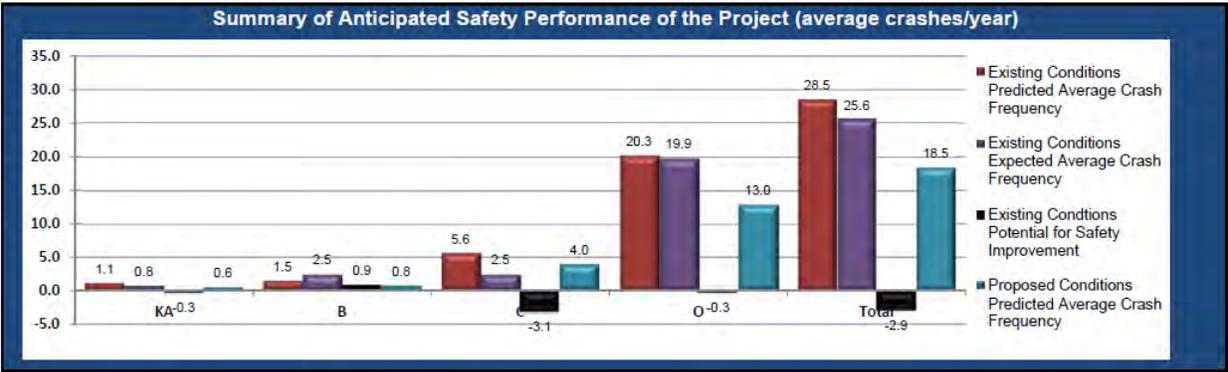
An analysis of crash data and the proposed countermeasures were performed using ODOT’s Economic Crash Analysis Tool (ECAT). The ECAT calculates predicted/expected crash frequencies using Safety Performance Functions (SPFs), Crash Modification Factors (CMFs), and ODOT calibration factors to evaluate site-specific conditions based on existing physical characteristics, traffic volumes, and crash history. The projected safety improvement for implementing long-term countermeasures is 10.0 crashes per year by reducing the existing conditions predicted crashes from 28.5 to a proposed conditions prediction of 18.5 crashes per year.

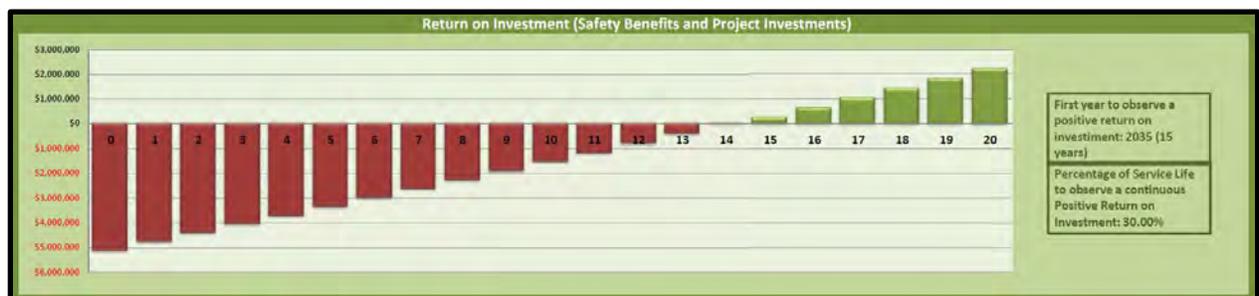
Benefit - Cost Calculator		Expected Annual Crash Adjustment	
Net Present Value of Project	\$5,117,620.00	Number of Fatal & Incapacitating Injury Crashes	-0.468
Net Present Value of Safety Benefits	\$4,942,467.73	Number of Injury Crashes	-2.436
Net Benefit	(\$175,152.27)	Number of Total Crashes	-9.160
Benefit / Cost Ratio	0.97

Use of ODOT's Economic Crash Analysis Tool (ECAT) for the proposed improvements revealed a 0.97 positive Benefit/Cost Ratio with the proposed countermeasures applied to the corridor. With these improvements it is expected that a positive return on investments will be observed after 15 years.

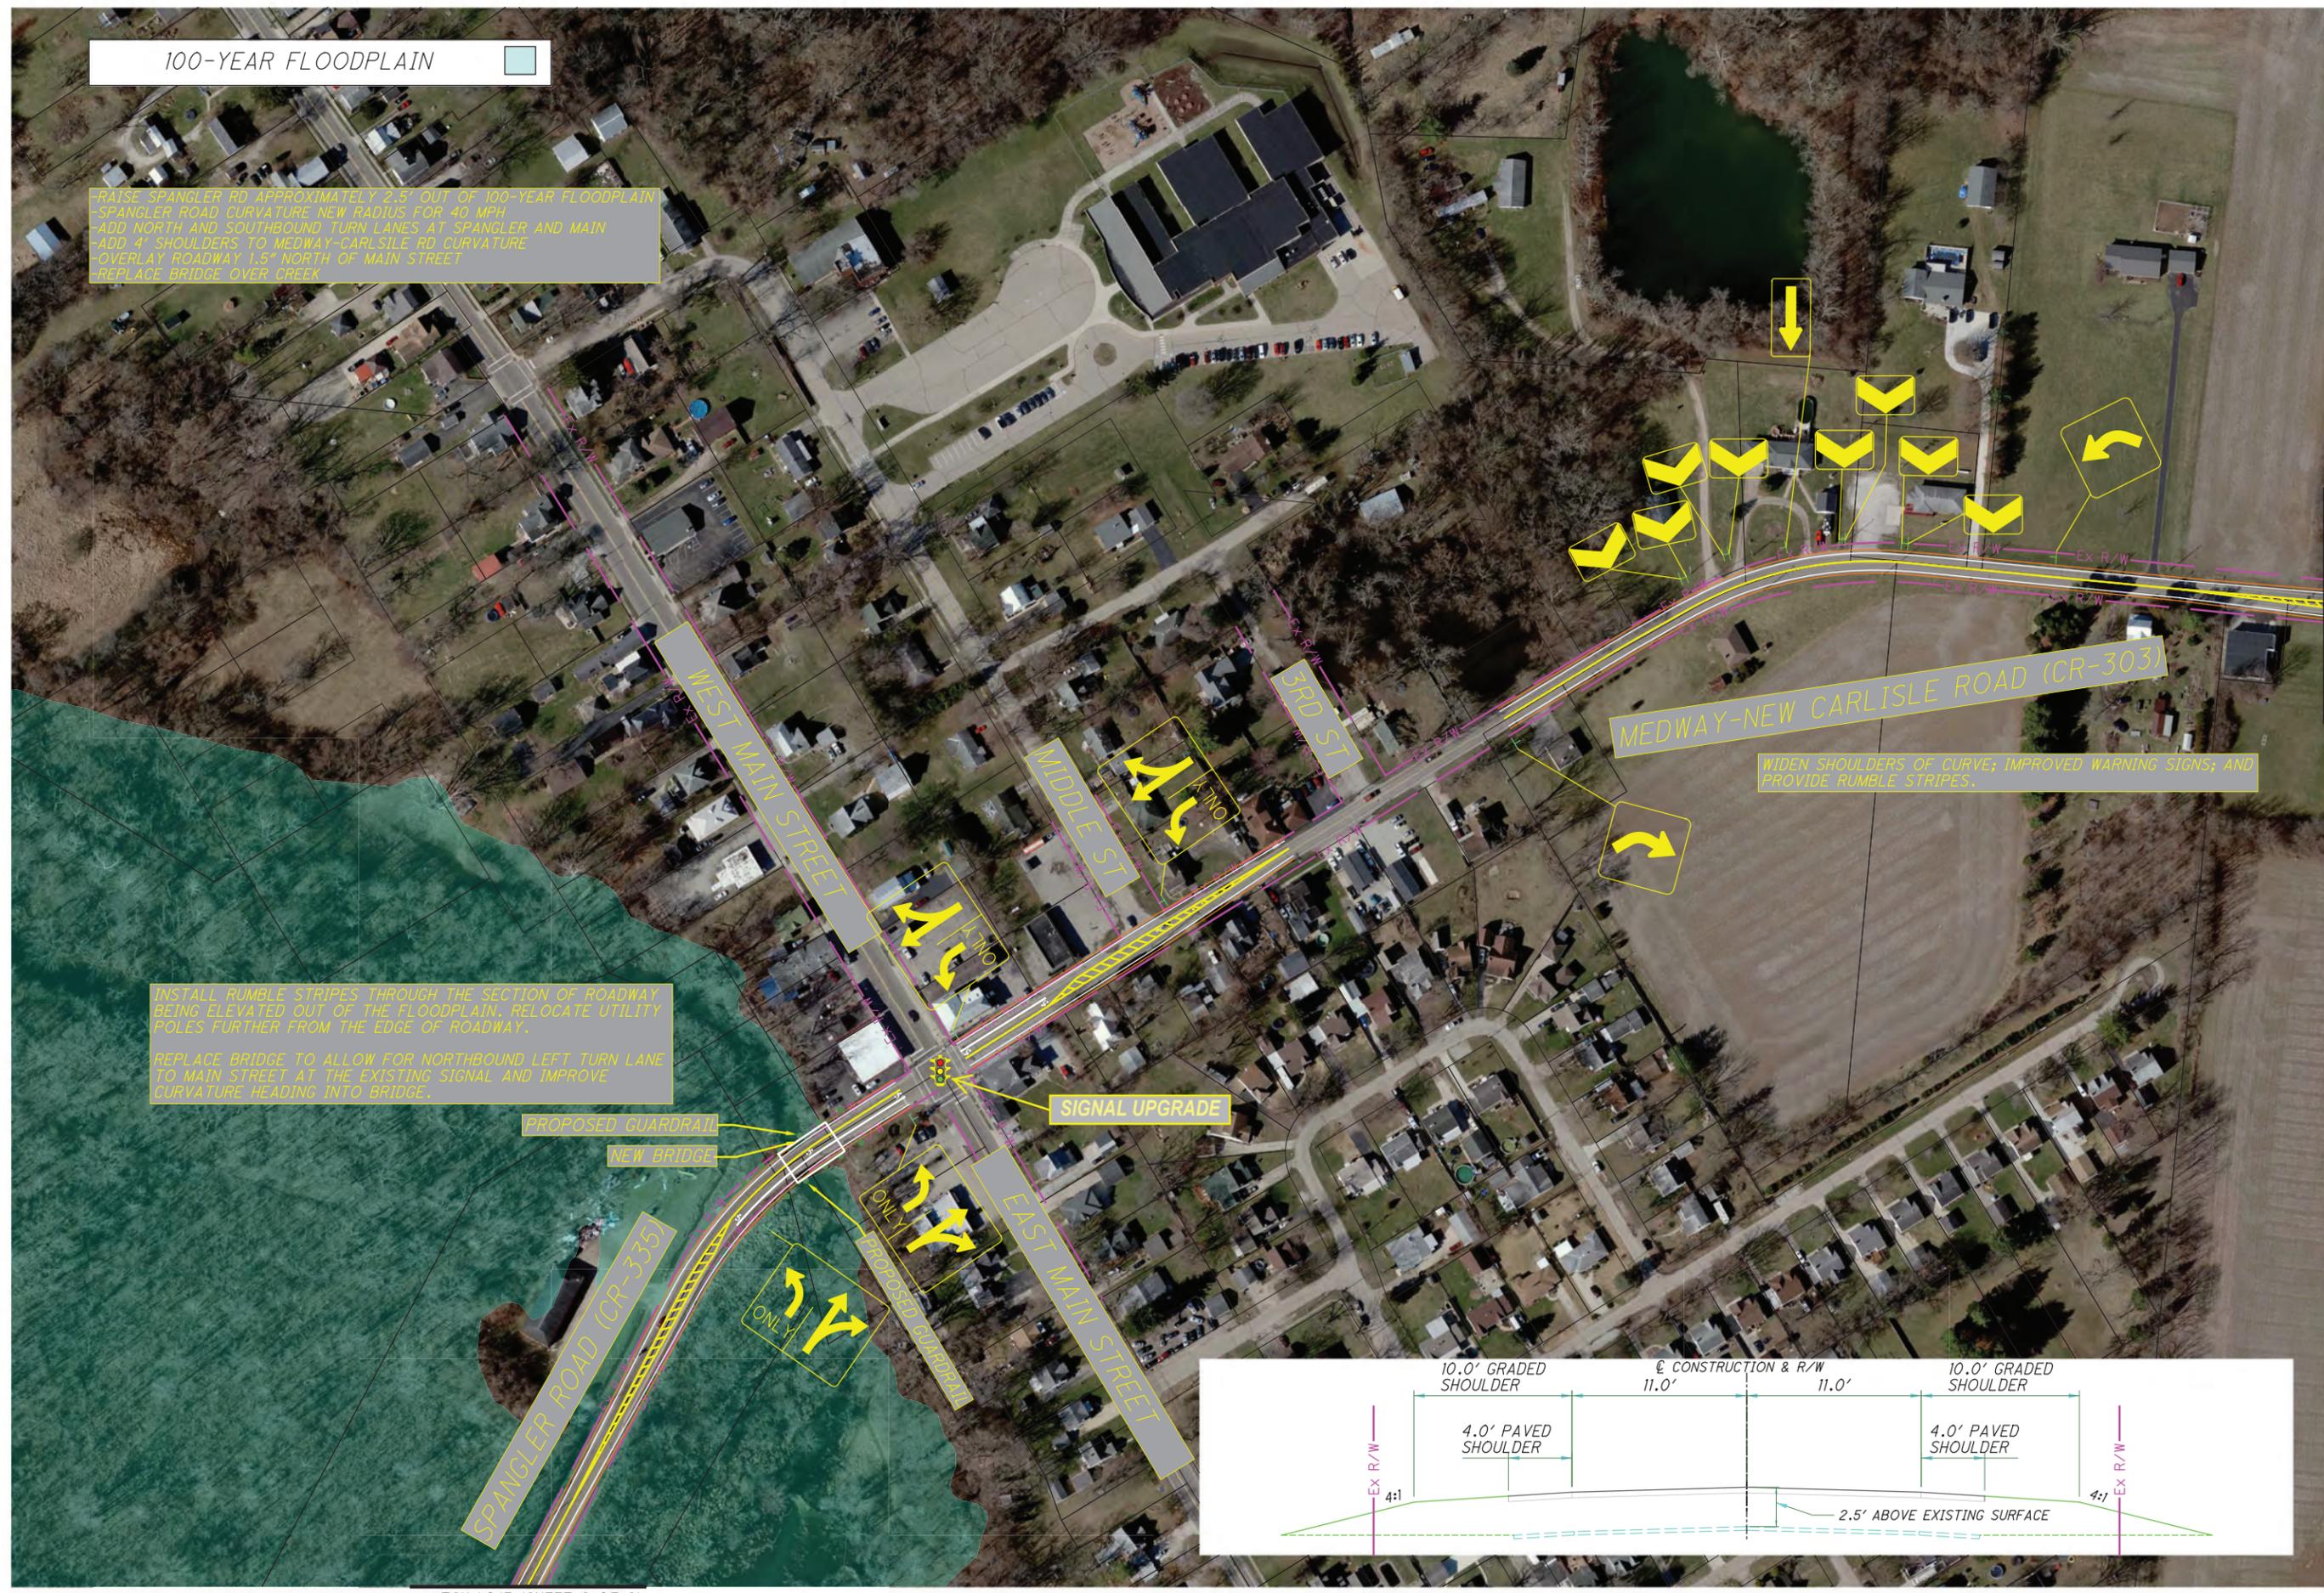
**FIGURE 5.1**  
**PROPOSED IMPROVEMENTS**

RAISE SPANGLER RD APPROXIMATELY 2.5' OUT OF 100-YEAR FLOODPLAIN  
- SPANGLER ROAD CURVATURE NEW RADIUS FOR 40 MPH  
- ADD NORTH AND SOUTHBOUND TURN LANES AT SPANGLER AND MAIN  
- ADD 4' SHOULDERS TO MEDWAY-CARLISLE RD CURVATURE  
- OVERLAY ROADWAY 1.5' NORTH OF MAIN STREET  
- REPLACE BRIDGE OVER CREEK

A summary of the proposed countermeasures for the CR335/CR303 corridor improvements are outlined in Table 5.1 below, as well as displayed on Figure 5.1. An analysis of crash data and the proposed countermeasures were performed using ODOT’s Economic Crash Analysis Tool (ECAT). The ECAT calculates predicted/expected crash frequencies using Safety Performance Functions (SPFs), Crash Modification Factors (CMFs), and ODOT calibration factors to evaluate site-specific conditions based on existing physical characteristics, traffic volumes, and crash history. The projected safety improvement for implementing long-term countermeasures results in 10.0 fewer crashes per year, as the countermeasures would reduce existing conditions predicted crashes from 28.5 to a proposed conditions prediction of 18.5 crashes per year. The Total cost of improvements is \$5,884,000.

The proposed improvements outlined in Table 5.1 have been displayed in the two designated County Route numbers associated with the corridor, with those being CR335 (Spangler Road) which is the segment south of Medway, and CR303 (Medway-New Carlisle Road) which is the segment north of Medway. All the improvements are shown on Figure 5.1. The overall project cost is estimated to be \$5,884,000. A review of collision diagrams revealed that the majority of crashes occurred on the 1.1-mile section of CR335 (Spangler Road) from Restoration Park Drive to Main Street in Medway as this section accounted for 57% (32 crashes) of the total 56 crashes and contained 73% (11 crashes) of the 15 fatal/injury crashes within the study limits. The remaining 2.0-mile section of the corridor study limits on CR303 (Medway-New Carlisle Road) contained 43% (24 crashes) of all crashes and 27% (4 crashes) of the fatal/injury crashes. The predominant crash type of the CR335 (Spangler Road) section included 18 Fixed Object crashes (56% of crashes on this section) that resulted in 7 injury crashes and one (1) fatal crash. The projected safety improvement for implementing all the long-term countermeasures results in 10.0 fewer crashes per year, as the countermeasures would reduce existing conditions predicted crashes from 28.5 to a proposed conditions prediction of 18.5 crashes per year.

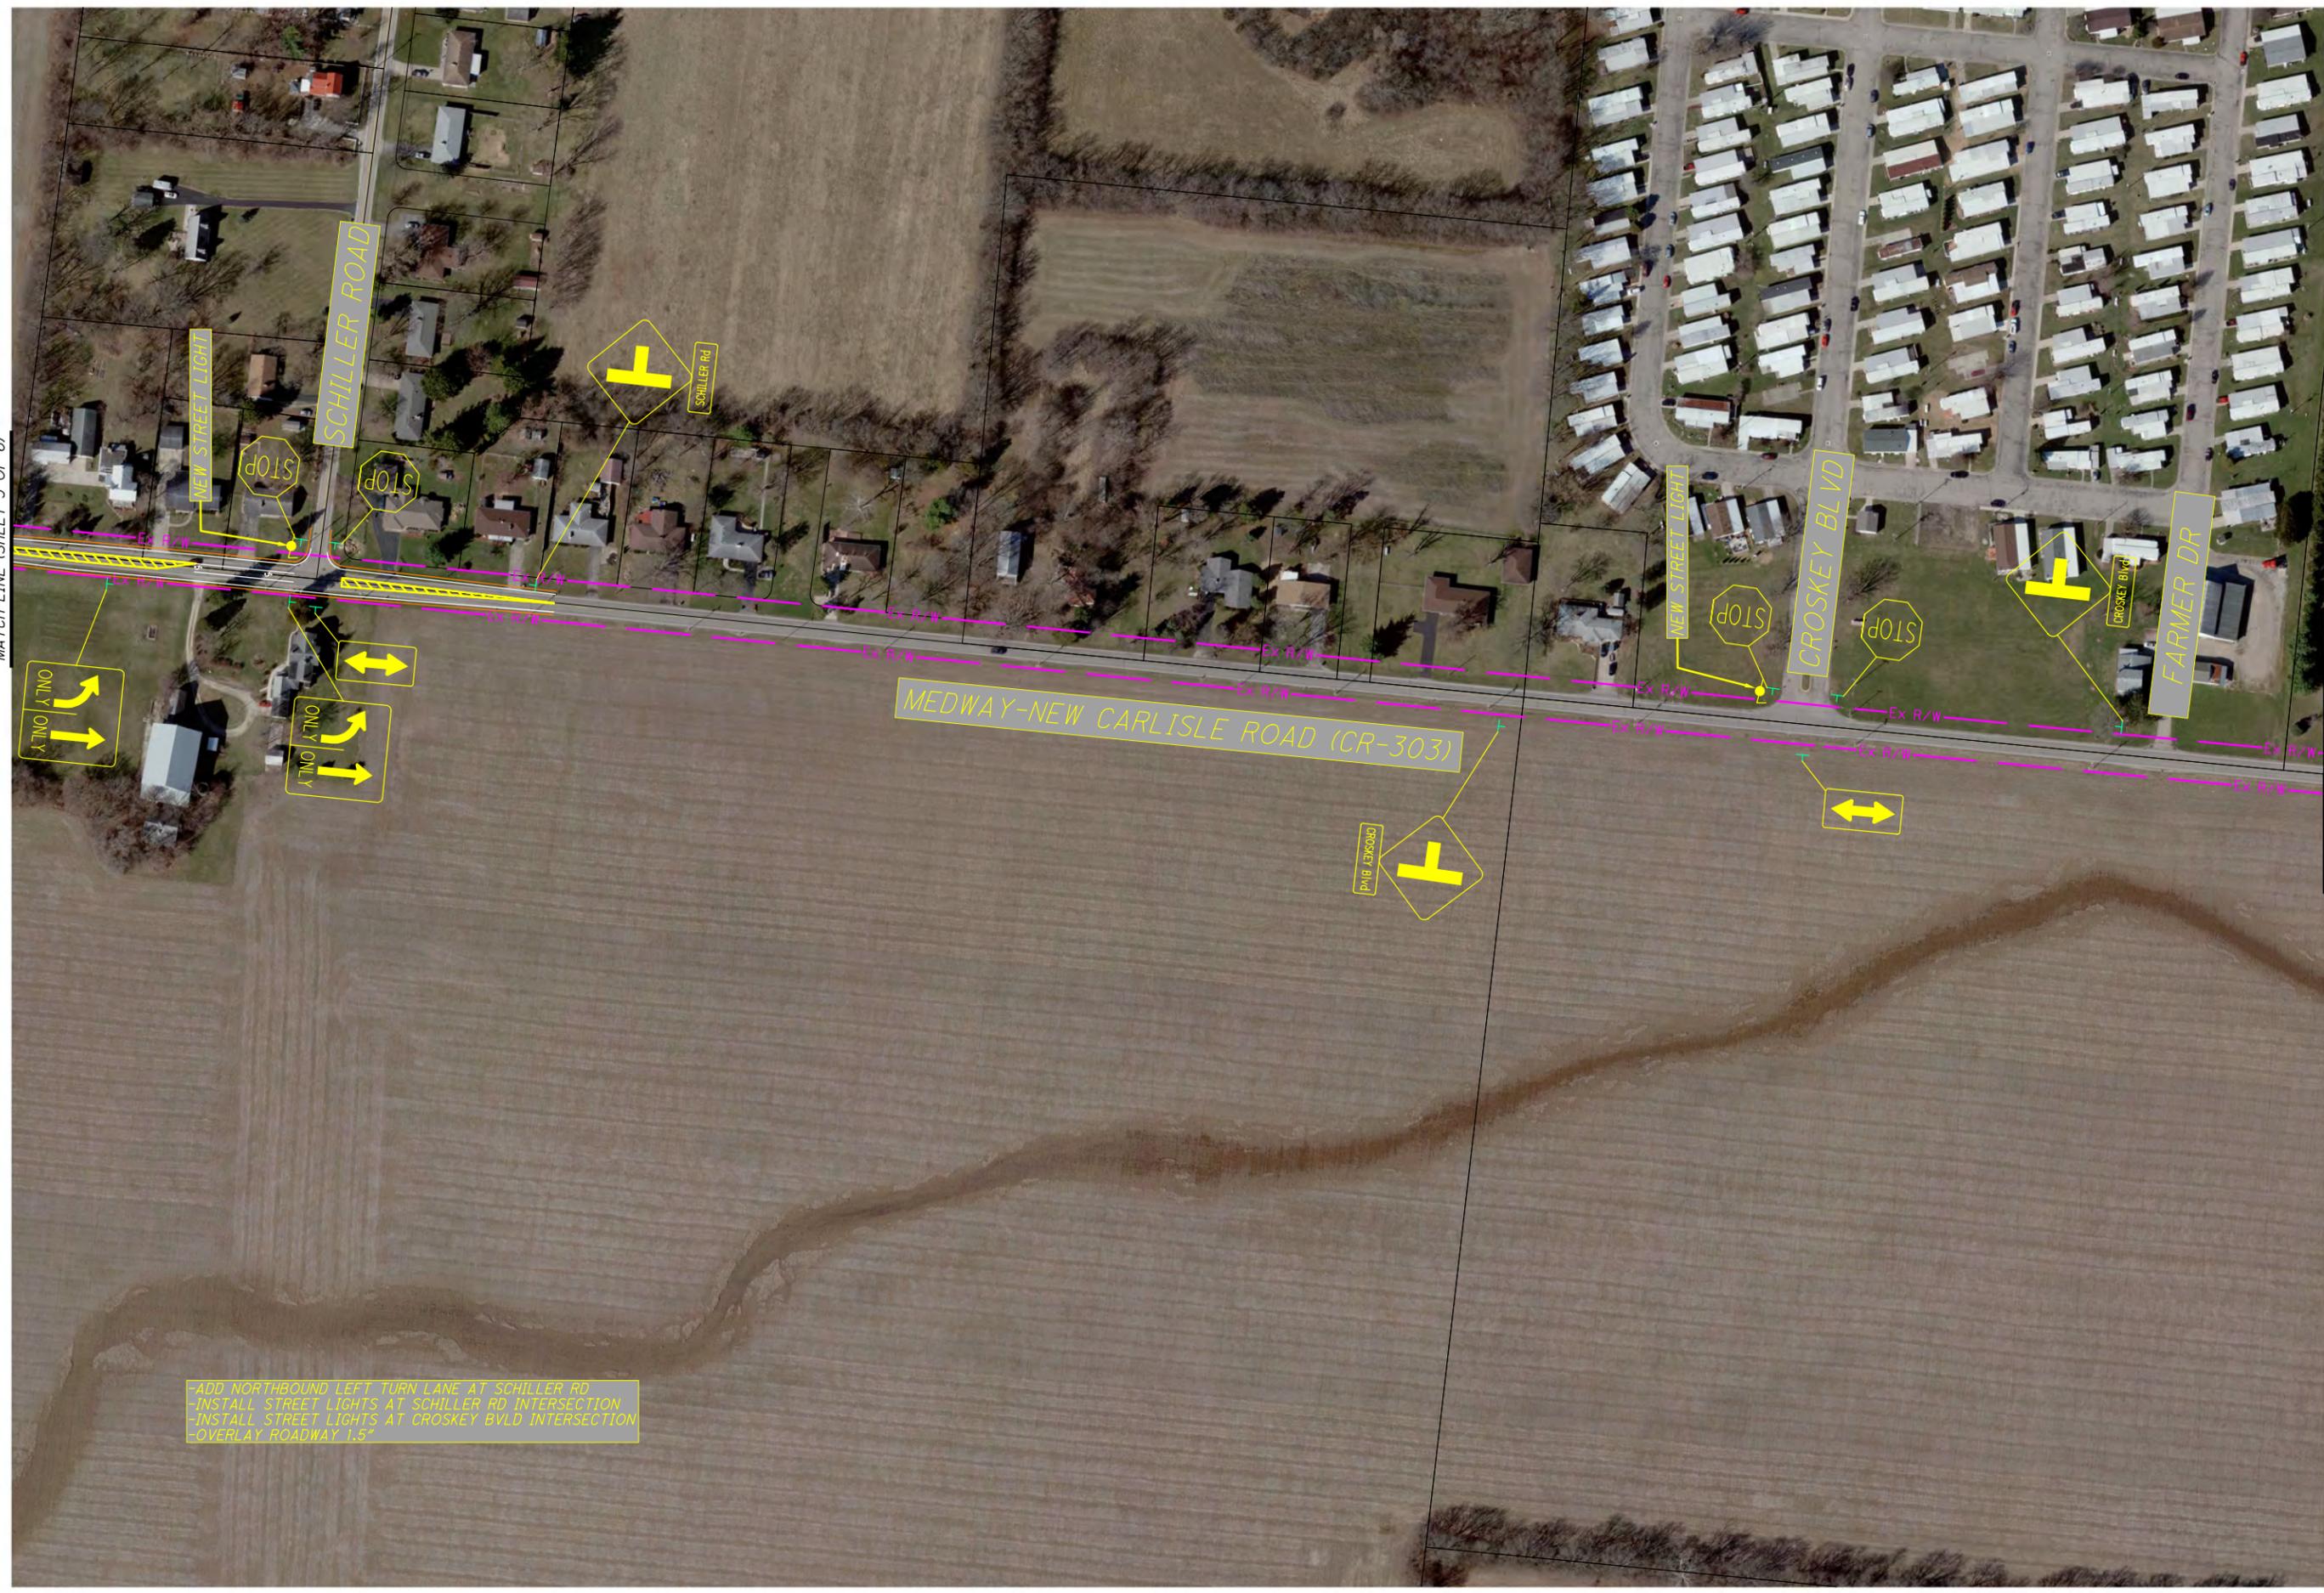
-ADD NORTHBOUND LEFT TURN LANE AT SCHILLER RD  
 -INSTALL STREET LIGHTS AT SCHILLER RD INTERSECTION  
 -INSTALL STREET LIGHTS AT CROSKEY BLVD INTERSECTION  
 -OVERLAY ROADWAY 1.5"

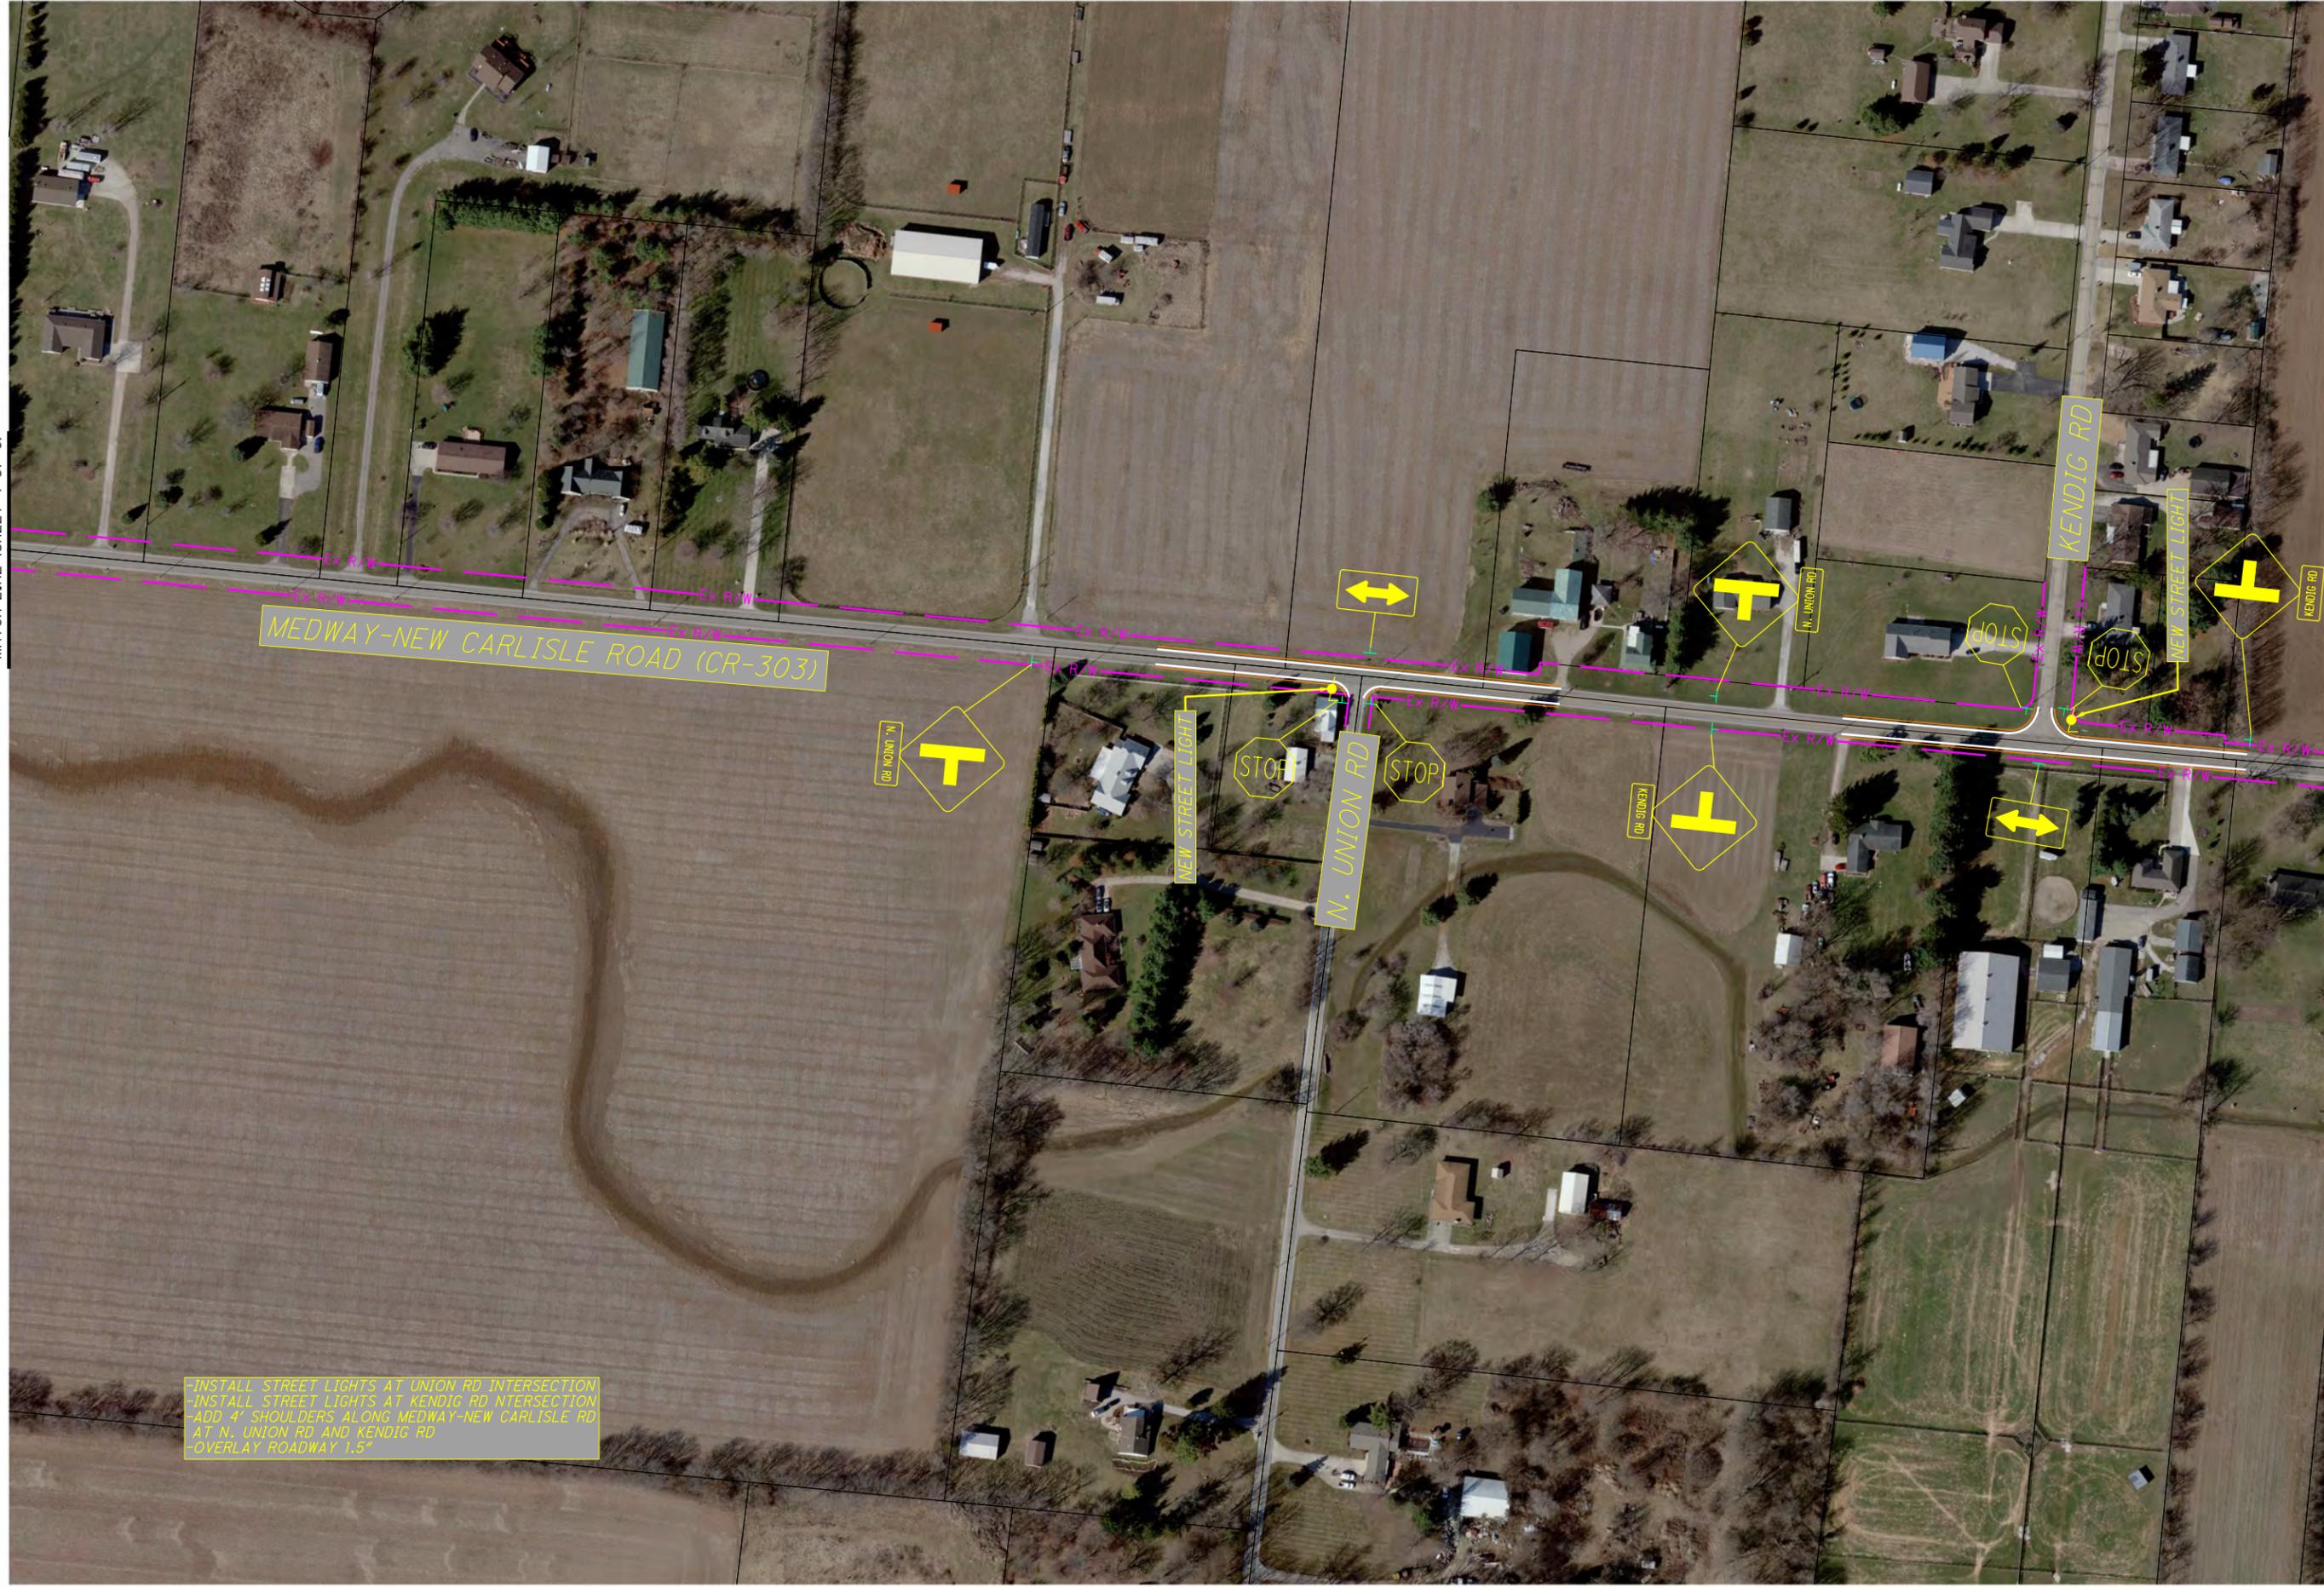
-INSTALL STREET LIGHTS AT UNION RD INTERSECTION  
 -INSTALL STREET LIGHTS AT KENDIG RD INTERSECTION  
 -ADD 4' SHOULDERS ALONG MEDWAY-NEW CARLISLE RD  
 AT N. UNION RD AND KENDIG RD  
 -OVERLAY ROADWAY 1.5"

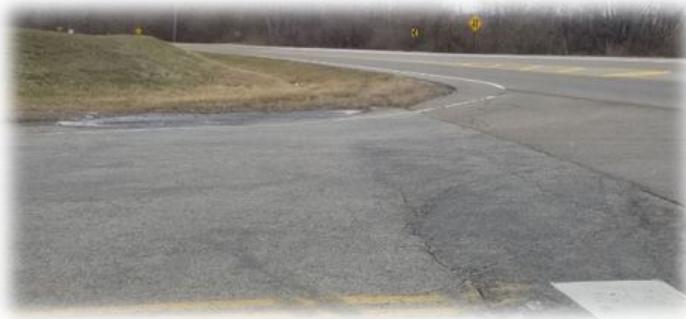
Limited sight distance at Restoration Park Drive looking northward for southbound traffic that is caused from the earth levee

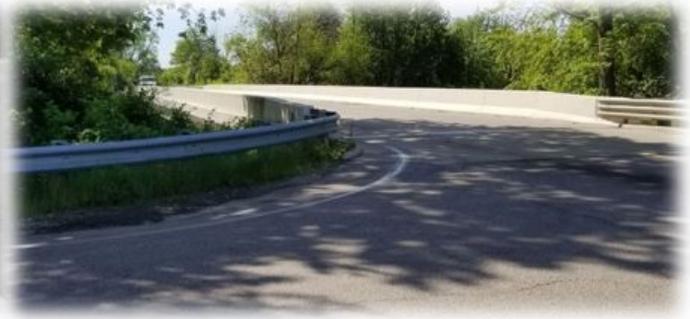
Limited sight distance at South Union Road looking southward for northbound traffic limited by intersection being too close to bridge

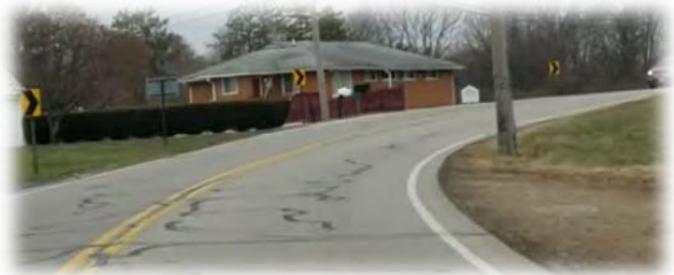
Curved sections within roadway corridor have limited shoulder widths and could use enhanced signing to warn motorists of the curves
